# REKONŠTRUKCIA ELEKTRICKOVÉHO TUNELA POD HRADOM V BRATISLAVE

## RECONSTRUCTION OF TRAM TUNNEL UNDER BRATISLAVA CASTLE

MILOSLAV FRANKOVSKÝ

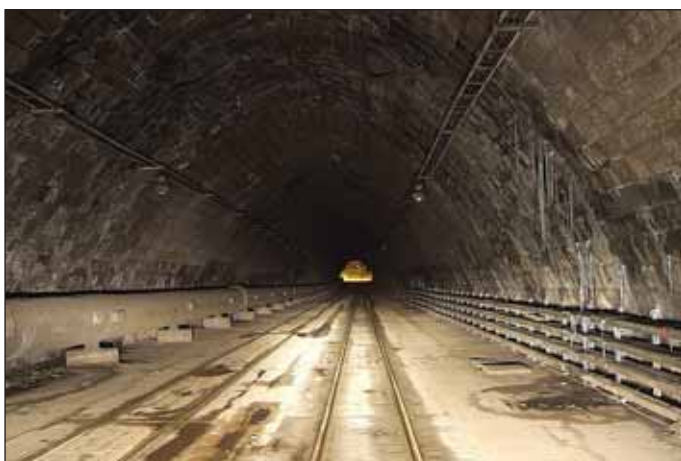
Stav tunela pred komplexnou rekonštrukciou (obr. 3) zodpovedal jeho veku, resp. času uplynutého od jeho poslednej veľkej rekonštrukcie v osemdesiatych rokoch minulého storočia. Dlhodobou neudržateľným stavom sa týkali viacerých častí stavby a jej vybavenia. Rozhodnutie o rekonštrukcii sa opieralo hlavne o tieto dôvody.

Obr. 3 Interiér tunela pred rekonštrukciou (foto M. Dekánek, 2009)  
Fig. 3 Tunnel interior before reconstruction (Photo courtesy of M. Dekánek, 2009)

The condition of the tunnel before the comprehensive reconstruction corresponded to its age or the time which had passed since the previous major reconstruction in the 1980s. The condition which was untenable for a long time comprised several parts of the structure and its equipment. The decision that the reconstruction would be carried out was mainly based on the following reasons:

Rails carrying concrete panels and the rails were in a poor technical condition; the head of rails was deformed, causing shaking and noise inside trams. Some stretches of the rails were worn to an extent which jeopardised the safety of the tram traffic.

The tunnel drainage was in a poor condition, the system of transverse drain holes, cross drains and longitudinal collecting drains was out of function in some blocks, contributing to deterioration of the rail track sub-grade.

Owing to the DN 800mm water pipeline lying on the surface between the southern sidewall and the rail track, a permanent access to the lining on the sidewall and elements of the drainage on the southern part of the tunnel was impossible. At the same time, the pipeline worsened conditions for the escape of people along the southern sidewall in the case of an emergency.

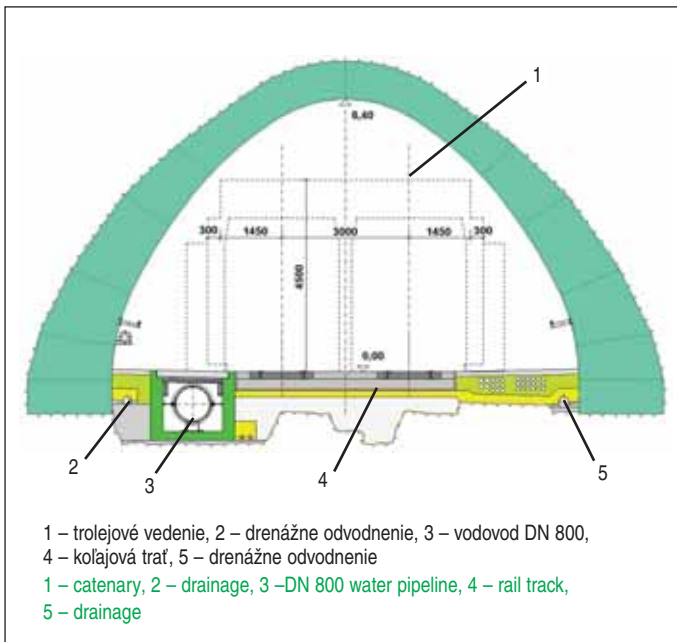
1 – trolejové vedenie, 2 – drenážne odvodnenie, 3 – vodovod DN 800, 4 – koľajová trať, 5 – drenážne odvodnenie  
1 – catenary, 2 – drainage, 3 – DN 800 water pipeline, 4 – rail track, 5 – drainage

**Obr. 4** Vzorový priečný rez tunela po rekonštrukcii  
**Fig. 4** Typical cross-section through the tunnel after reconstruction

Plán pod koľajovou traťou bola vyhlbená na skalné podložie, pričom boli odstránené pôvodné prvky odvodnenia. Vybratá bola aj nefunkčná vodovodná oceľová rúra priemeru 600 mm, nachádzajúca sa pod koľajovou traťou, ktorá nebola odstránená počas predošlej rekonštrukcie. Vzniknutý priestor bol vyplnený zhutneným drveným kamenivom frakcie 32/63 až po úroveň vrstvy z drenážneho betónu (obr. 4).

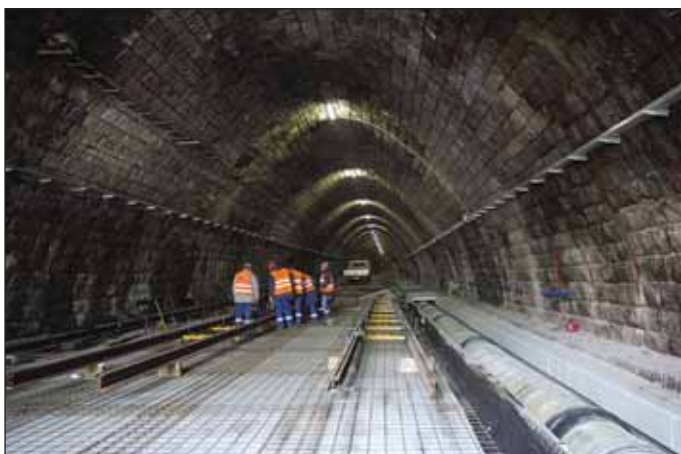
Obr. 6 Výstavba koľajovej trate, vpravo potrubie vodovodu v kanáli  
Fig. 6 Construction of the rail track; for the right: the water pipeline in the duct

The existing elevated water line was replaced by an 800mm-diameter ductile cast iron pipeline placed into an underground reinforced concrete duct running next to the rail track, along the southern sidewall. The duct is covered throughout its length with precast slabs. The water pipeline was extended in front of both portals during the reconstruction. The extensions were placed in a reinforced concrete duct, similarly to the pipeline inside the tunnel. On the one hand, the decision that the pipeline would be extended complicated the course of the reconstruction, but on the other hand, it brought an unambiguous positive in the form of the exclusion of a possibility of disrupting the tram traffic in the case of a defect on the pipeline.

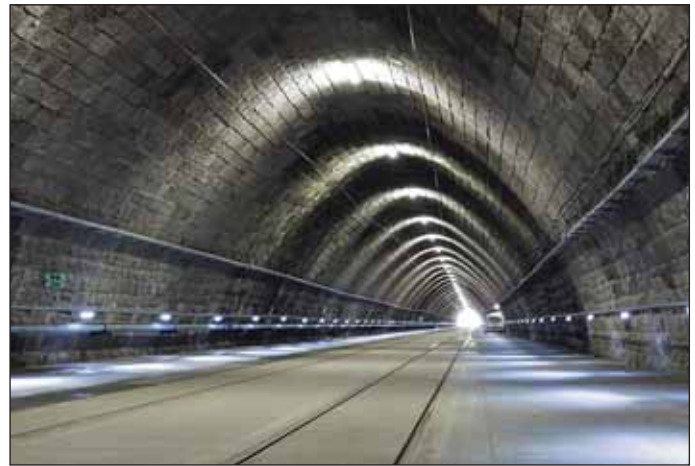
Obr. 8 Interiér tunela po rekonštrukcii  
Fig. 8 Tunnel interior after reconstruction
