REKONSTRUKCE JAROVSKÉHO ŽELEZNIČNÍHO TUNELU

RECONSTRUCTION OF THE JAROV RAIL TUNNEL

OTAKAR HASÍK, MIROSLAV CHYBA

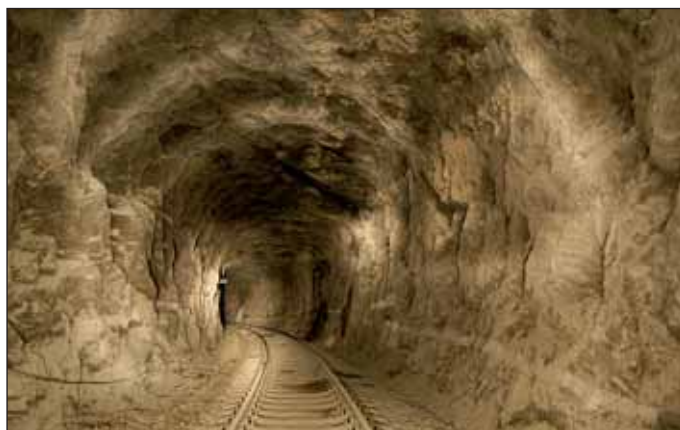
Obr. 2 Hlavní část tunelu je ponechána bez ostění
Fig. 2 The main part of the rock excavation is left unlined

Tunel dlouhý 393 m je obezděn jen v příportálových úsecích v délkách cca 70 m, hlavní část tunelu je ponechána jen ve skalním výrubu (obr. 2). Obezdvíčka portálu k Vranému n. Vltavou byla v havarijním stavu, prvních 40 m bylo podskruženo ocelovými oblouky a dřevěnými pažnicemi a rychlost průjezdu vlaků zde byla omezena na 10 km/h.

The 393m long tunnel is provided with a lining only in about 70m long portal sections, whilst the rock surface in the main part of the tunnel is bare (see Fig. 2). The lining of the portal on the side toward the village of Vrané n. Vltavou was in an emergency condition; the initial 40m long section of the tunnel was supported by steel frames and wooden lagging. The speed of passing trains was restricted to 10 km/h.

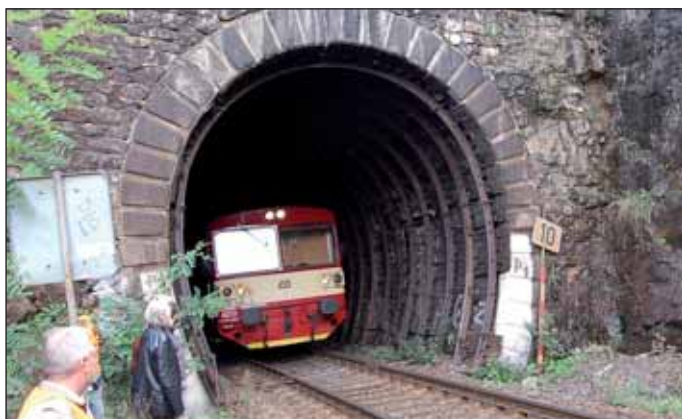
Obr. 3 Portál a prvních 40 m s provizorním zajištěním
Fig. 3 The portal and initial 40m with a temporary support

Směrem zevnitř tunelu k portálu se po záběrech odstraňovaly ocelové oblouky a dřevěné pažiny provizorního zajištění, vybourala se stávající obezdívka v klenbě a následně i v opěrách, vyrubal se zvětšený průřez v klenbě do požadovaného tvaru. Následovalo dočasné zajištění primárním ostěním jako při postupu podle NRTM tvořené kotvami a stříkaným betonem C 20/25 v tloušťce cca 50–100 mm s jednou výztužnou sítí.

The steel frames and wooden lagging forming the temporary support were removed stepwise, in individual advances proceeding from the tunnel interior toward the tunnel portal, the existing masonry lining was removed first in the vault and then on the sides and the excavated cross section was enlarged in the crown to the required shape. The installation of the temporary support followed. It consisted of the surrounding rock mass which was reinforced by anchors and a 50 – 100mm thick layer of C 20/25 sprayed concrete with one layer of steel mesh.

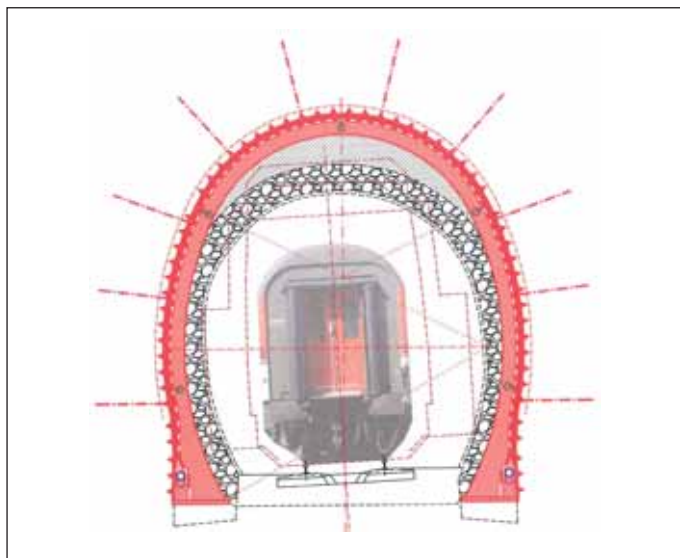
Obr. 4 Příčný řez původního a rekonstruovaného tunelu
Fig. 4 A cross section of the original tunnel and reconstructed tunnel

Protože bylo zadáno, že hlavní práce rekonstrukce tunelu proběhnou za úplné výluky tratě, bylo navrženo alternativní řešení rekonstrukce, které při zachování koncepce původního projektu přináší moderní spolehlivé řešení izolace a konstrukce ostění a vychází ze současného strojního vybavení a zkušeností firmy Subterra a. s. Úprava spočívá zejména v tom, že opěry jsou rekonstruovány stejně jako klenba.

Because the tender conditions allowed the contractor to carry out the principal items of the works during a complete closure of the line to traffic, an alternative design for the reconstruction was approved which, while maintaining the concept of the original design, provides a modern and reliable solution to the waterproofing and lining structure and, in addition, is based on the existing mechanical equipment and Subterra's experience. The main item of the design modification is that the sidewalls are reconstructed concurrently with the vault.

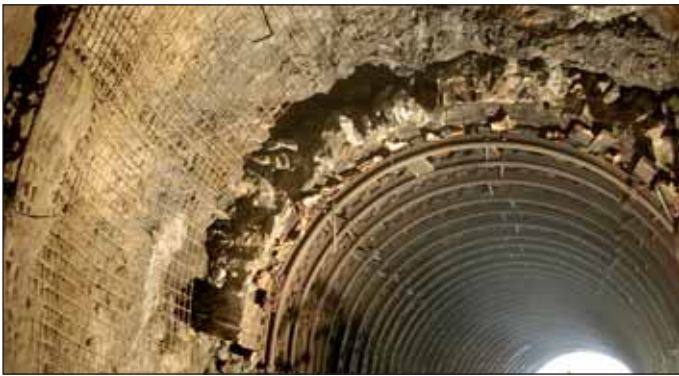
Obr. 5 Detail pobírání skalního masivu a původní obezdívky
Fig. 5 A detail of the breaking of the rock and the original masonry lining

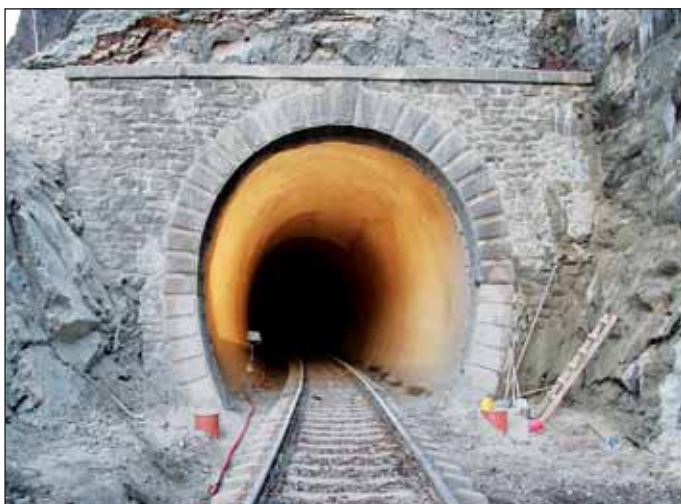
Obr. 6 Rekonstruovaný tunel
Fig. 6. The tunnel after reconstruction

Definitivní (sekundární) ostění o celkové tloušťce 250 mm je ze stříkaného betonu C 25/30 XF1 vyztuženého dvěma polohami svařovaných sítí připojených na výztužné oblouky. Ostění se nastříkávalo po jednotlivých pasech délky cca 10 m. První pracovní spára po 10 m za portálem je dilatační. Jeden výklenek byl vybudován 25 m od portálu napravo, na straně do hory, resp. na stejné straně jako je stávající výklenek cca 50 m od portálu.

The final (secondary) 250mm thick lining consists of C 25/30 XF1 shotcrete, support frames and two layers of welded mesh, which are fixed

to the frames. The lining was sprayed stepwise, in about 10m long blocks. The first day joint, which is 10m behind the portal, is of the expansion type. One safety recess was provided at a distance of 25m from the portal, on the site toward the rock massif (on the same side where there is an existing recess – about 50m from the portal).
