THE UMIRAY – MACUA TUNNEL, A GUARANTEE OF DRINKING WATER FOR MANILA

PAVEL BLÁHA, ROMAN DURAS, JAN FOUSEK, JITKA NOVOTNÁ

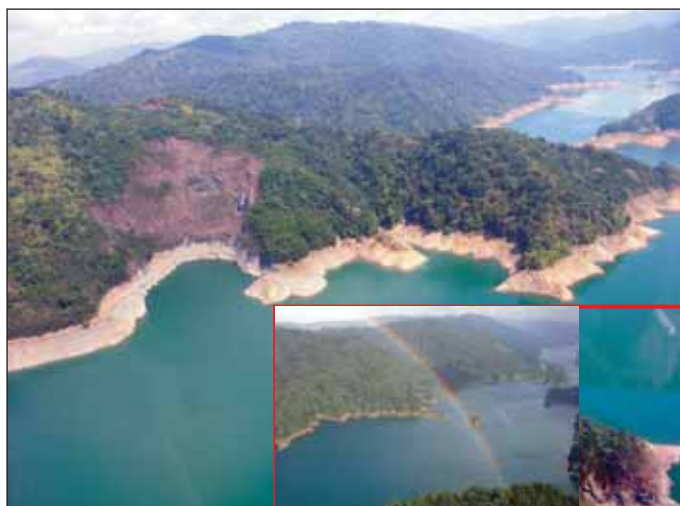
Of course, such the extreme rains were bound to affect the area around the dam. The banks of the reservoir were stripped of all vegetation during the course of the typhoon. The effects reached not only the level of water surface in the reservoir; the vegetation cover was removed by beating of waves (induced by the typhoon) up to the level which corresponded to the maximum magnitude of waves. We should realise that the velocity of air during Nanmadol typhoon reached up to 320kph. The banks of the reservoir were, as a result of the above-mentioned phenomena, affected up to the elevation of 230m a.s.l. (see Fig. 5). Nevertheless, owing to the self-regeneration power of nature, the slopes around the reservoir were again covered with grass and low bushes during the two years after Nanmadol typhoon (see the photo in Fig. 5).

Obr. 5 Letecký pohled na přehradní jezero Angat 10 týdnů po tajfunu a dva roky po tajfunu
Fig. 5 Aerial view of the Angat reservoir, 10 weeks after the typhoon and two years after the typhoon

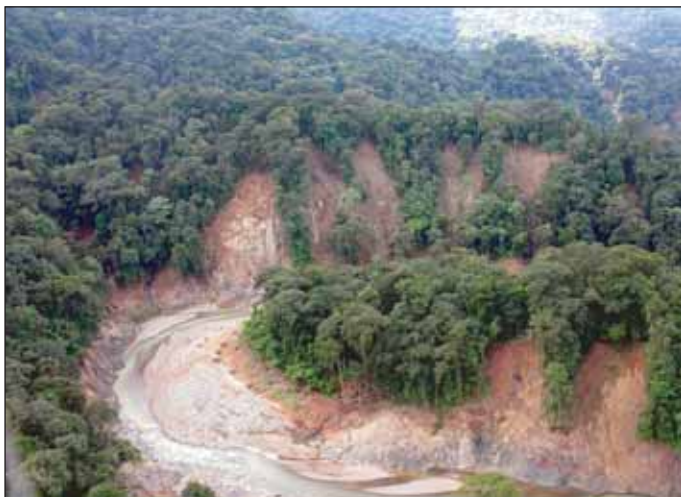
As mentioned above, the precipitation accompanying the typhoon exceeded 1000mm. The increased amount of water could not freely flow away on the ground surface to local water courses and seeped into the soil cover. Conditions suitable for developing slope deformations started to originate

Obr. 6 Svahové deformace na březích řeky Umiray
Fig. 6 Slope deformation on the Umiray River banks

on the banks of the reservoir, along rivers and streams, and on mountain slopes. The enormous seepage of water into the cover frequently resulted in liquefaction of rock debris, which started to flow down the slopes to streams and rivers (see Fig. 6). The speed of movement of such slope deformations is very high; it may reach even tens of kilometres per hour. Even the movement of such bodies alone has catastrophic consequences. In the case of an uninhabited tropical forest, vegetation cover is the only subject of devastation. Accumulation parts of the slope deformations were immediately washed and transported further, in the water flow direction, to a valley or even down to the Angat reservoir itself, depending on the flow rate and gradient of the stream bed. At that moment, the volume weight of the mixture consisting of water and floating sediments may increase up to 1.4 g.cm^{-3} , thus the erosive action of the river may intensify. This is how the Umiray River banks were stripped of all vegetation and the Quaternary cover up to the level of 8 – 10 metres was removed.

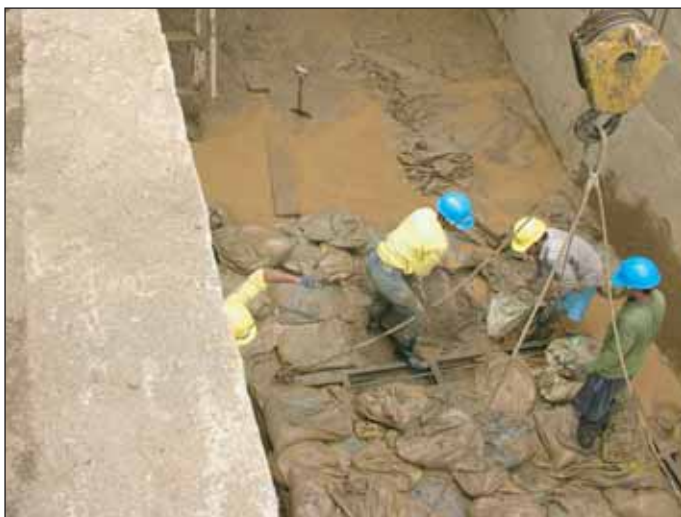
Obr. 8 Pohled na ruční čištění nápuštěného kanálu vstupu tunelu
Fig. 8 A view of the manual cleaning of the feeding canal at the tunnel intake structure

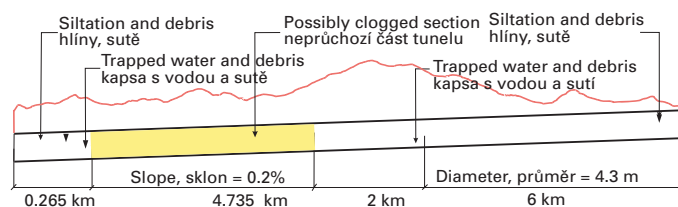
Obr. 7 Řez zaneseným tunelem (podle materiálů firmy EDCOP)
Fig. 7 A section through the silted tunnel (according to EDCOP company materials)

Virtually the whole tunnel intake structure was destroyed during typhoon Nanmadol and the subsequent flood, which was more intense in the Umiray River catchment area. Because of the fact that the tunnel tube had been neither protected nor inundated in a controlled manner, the flood wave even got inside the tunnel and filled it with various sediments. The condition of the tunnel interior after the flood is shown in Fig. 7. Significant part of the tunnel was completely inaccessible and the remaining section was filled with a mixture of water, loam, stones and organic matter. It was no exception to find whole trees with trunk diameters exceeding 0.5 metre in the tunnel. The character of the sediments in the tunnel, a chaotic mixture of organic and inorganic matter consolidated by pressure induced by flowing water, is shown in the photos in Figures 8 and 9, which show the condition about 2.5 months after the typhoon. The picture even shows the tunnel cleaning operation, which could not be performed by equipment and all the work had to be carried out manually. The tunnel was again put into operation as late as March 2005, after reconstruction of necessary components; however, for example the cable supplying power for buildings at the tunnel intake receiving water from a small hydroelectric station was not replaced till the time of our last visit.

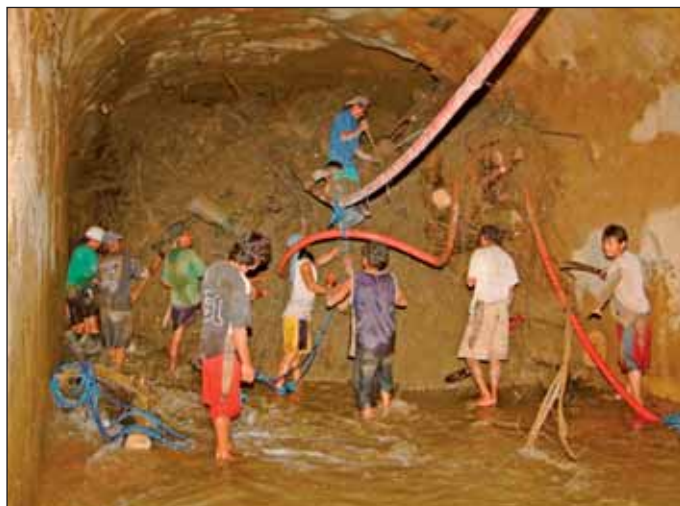
Obr. 9 Pohled na ruční čištění výtoku zaneseného tunelu (foto firmy EDCOP 2005)
Fig. 9 A view of the manual cleaning of the outlet of the silted tunnel (photo by EDCOP 2005)

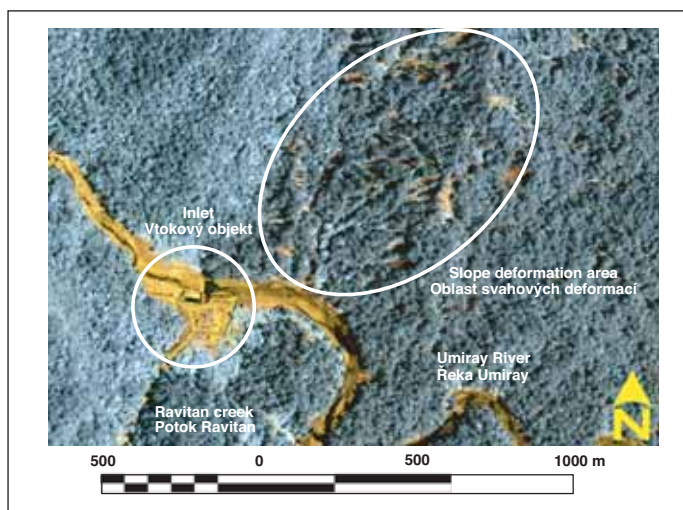
Obr. 10 Satelitní snímek IKONOS, pohled na vtokový objekt a svahové deformace
Fig. 10 IKONOS satellite image; a view of the inlet structure and slope deformations

resolution images. A section of the images provided by this satellite is presented in Figure 10. The picture was processed using unrealistic colours, which means that red and green colour zones and the close infra zone were used for the imaging. We chose this combination with the aim of reducing the flaring of the intake structure. In this section, it is possible to see individual structures in the intake area and numerous slope deformations north-east of the intake structure. We have not succeeded in explaining the causes of the fact that land sliding affected only a part of the area. Since it has been impossible to enter the area because of the fact that the time of staying on the intake structure is limited, we have not addressed this problem yet. We expect that the slope deformations were caused by a combination of the geological structure of the area and the amount of precipitation which fell within the given area. It is likely that we will try to get to some of the slope deformations by helicopter, to determine the causes of the varying affection of slopes by mass movements.

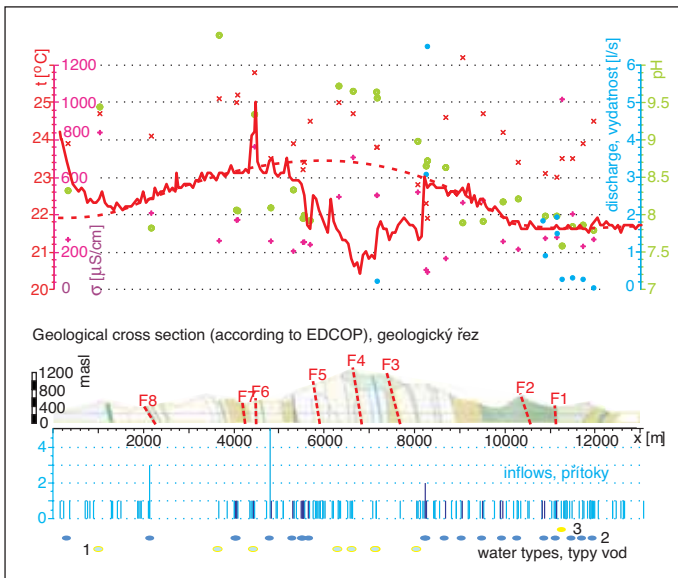
Fig. 12 Measurements in the tunnel:

- upper part: temperature of the lining; temperature, conductivity and pH of inflowing water
- central part: geological section and determination of rock types, according to EDCOP documents
- bottom part: locations of leaks, types of water

The measurements in the tunnel which we conducted in November 2007 provided lots of new information. The results of all the measurements are presented in Figure 12. Ground water types are demonstrated at the bottom of the picture (details are available in the text below). The inflows of ground water into the tunnel, as we managed to record them during a passage through the tunnel, are presented above them. The locations where inflow rates higher than about 1 l/s were encountered are marked in blue colour, while green colour marks all other, smaller leaks. The inflows have turned out to be more significant than we expected at the moment of the survey. The highest inflow rate which we recorded was at 8272m, where about 6.5 l/s flew into the tunnel. This amount is not a result of guessing; it was measured by means of a measuring vessel with the volume of 80 l. Next time, we plan that we will again document all inflows during the course of an inspection walk through the tunnel to get the idea of changes in the hydrological regime during a year. We verified the yield of eleven springs between chainages m 7,159 and 11,959 by direct measurements. We selected higher-yield springs, where the yield ranged from

0.04 l/s to the above-mentioned 6.5 l/s. Results of the measurements are presented at the top of Figure 12 by means of dark-blue points. Some of the tunnel inflows were dealt with during the installation of the tunnel lining. A short pipe through which water flows into the tunnel was embedded in the tunnel lining at each of the springs. One of the water inflows into the tunnel is presented in Fig. 13. Remaining inflows developed by themselves; water created holes in the lining during the tunnel operation, allowing water to flow into the tunnel tube. We have not surveyed the exact proportion of both inflow types, but we guess that both types are represented equally.

One of the most important measurements in the tunnel was the measurement of temperature of the tunnel lining. We measured the temperature by an infrathermometer, from a moving vehicle. The identified differences are surprisingly great, with the main anomalous zone found between approximately 5500 metres and 8200 metres. In contrast to a normal block, the temperature in this tunnel section is lower. If we assume a smooth course of temperature in the tunnel, following the red dot curve, the magnitude of the temperature anomaly in the middle of the tunnel reaches practically three degrees centigrade. The cause of the cooling of the rock mass must be searched for in the groundwater flow.

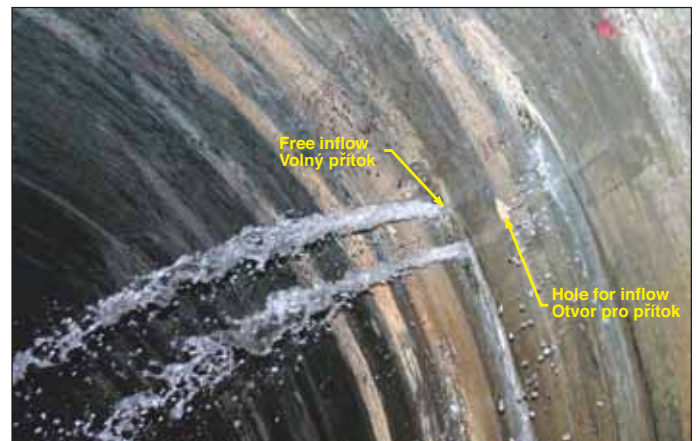
Fig. 13 Inflow of water into the tunnel

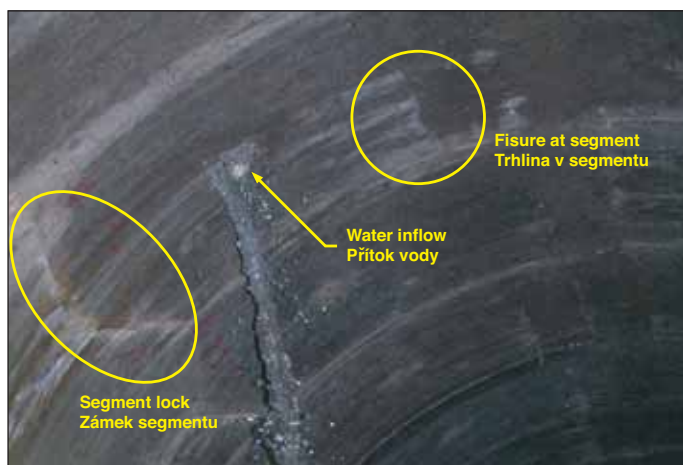
Obr. 14 Trhлина v segmentu ostění
Fig. 14 A crack in a lining segment

While documenting the inflows of water into the tunnel, we found out that there were cracks in lining segments and numerous sinter crust patches are on the segments (see Fig. 14). We did not record these facts in a more detailed way. The reason is the fact that the time available for the access to the tunnel was limited. The access to the tunnel is possible only in the period during which it is closed, which is usually once in four to six weeks. Even in such the case it is possible to stay in the tunnel for six hours as the maximum.
