# TUNEL ŽILINA, STAVBA KTORÁ PREVERILA ODBORNÚ ZDATNOSŤ ZHOTOVITEĽA

## ŽILINA TUNNEL, A PROJECT THAT TESTED CONTRACTOR'S PROFESSIONAL CAPACITY

MICHAL FUČÍK, IVETA ŠNAUKOVÁ

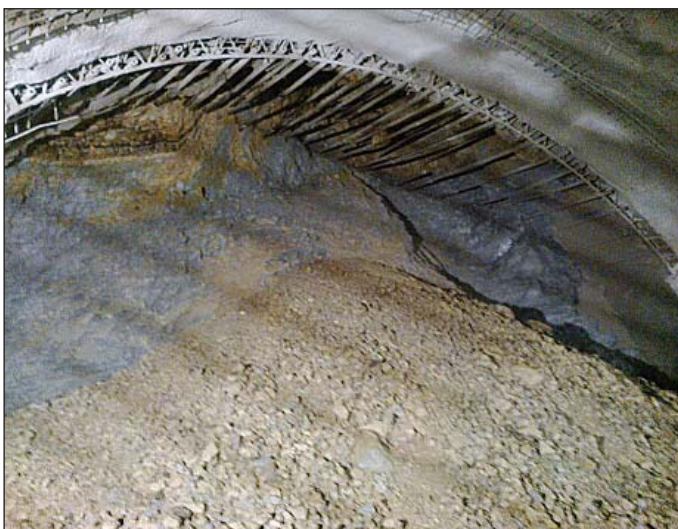
Čo však bolo neočakávané a nedalo sa to vopred predpokladať, bolo nadmerné vysypávanie horninového materiálu z čelby kaloty. Vysypávanie horniny nijak nezodpovedalo deklarovanému plastickému chovaniu horninového prostredia. Hornina sa hlavne vo vrchnej časti kaloty začala chovať ako sypký, nesúdržný materiál. Zabezpečenie kaloty kotvami z betonárskej ocele, ako aj zaistenie klenby kaloty ihlami, sa ukázalo ako neúčinné (obr. 1). Drobné úlomky zvetraného ílovca sa vysypávali medzi ihlami a ich vysypávanie z čelby znemožňovalo stabilizačný nástrek striekaným betónom. Nastal problém s vrtmi pre ihly a kotvy, ktoré sa už počas vŕtania začali zavaľovať a nebolo ich možné použiť na inštaláciu vystrojovacích prvkov. Hlavné návrhové kritérium, ktorým bolo čo najrýchlejšie uzatváranie výrubu za čelbou, na jednej strane znižovalo deformácie výrubu, ale na druhej strane malo nepriaznivý dopad na stabilitu čelby, pretože zvyšovalo riziko jej zosunutia. Zastihnuté nepriaznivé prejavy horniny v okolí výrubu postupovali veľmi rýchlo, a napriek operatívnejmu prístupu zhotoviteľa vyústili až do dvoch mimoriadnych udalostí – zavalov.

Obr. 1 Vysypávanie zeminy medzi ihlami v klenbe kaloty  
Fig. 1 Spilling of soil between needles in the top heading vault

But what was unexpected and could not be expected in advance was the excessive spilling of ground material from the top heading excavation face. The spilling of rock not at all corresponded to the declared plastic behaviour of the ground environment. The ground, first of all in the upper part of the top heading, started to behave as a loose, incohesive material. The support of the top heading excavation with anchors from concrete reinforcement bars and stabilisation of the top heading vault with needles turned out to be ineffective (see Fig. 1). Small fragments of weathered claystone spilled down between the needles and spilling from the excavation face made the application of stabilising shotcrete impossible. A problem appeared regarding boreholes for needles and anchors. They started to collapse during the drilling operation and could not be used for the installation of the excavation support elements. The main design criterion, closing the excavated space behind the excavation face with primary lining as fast as possible, on the one hand reduced the excavation deformations, but on the other hand, adversely affected the excavation face stability because it increased the risk of the collapsing face. The adverse manifestations of the ground in the excavation surroundings encountered proceeded very rapidly and, despite the operative attitude of the contractor, resulted to two extraordinary events – excavation collapses.

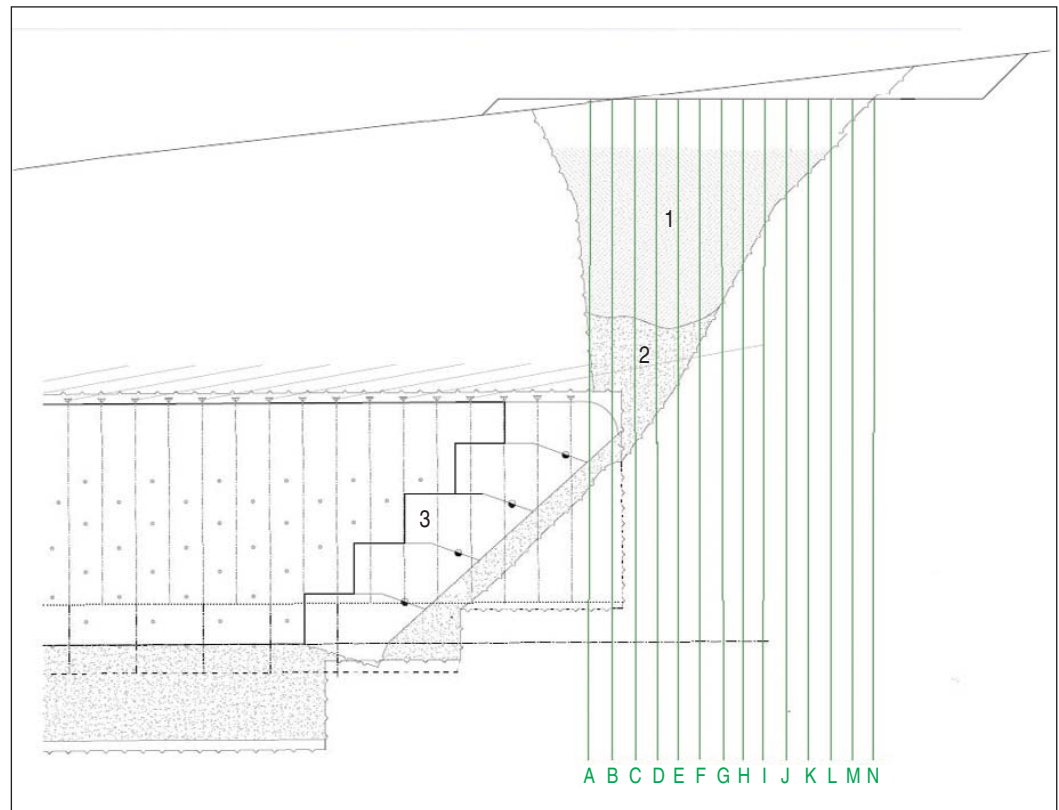
Obr. 2 Zmáhanie mimoriadnej udalosti – oporná betónová stena, 1 – výplň závalu, betón min. pevnosti C12/15, 2 – zával, 3 – betónová oporná stena, A–N – vejáre tryskovej injektáže

Fig. 2 Coping with the extraordinary event – retaining concrete wall, 1 – collapse backfill, minimum strength concrete C12/15, 2 – collapse, 3 – concrete retaining wall, A–N jet grouting fans

The collapse of the tunnel excavation face was in both cases caused by a combination of unfavourable factors, such as tectonic faulting of the massif, the increasing reach of weathering, degradation of the massif and increased presence of ground water. The depth range of the medium weathering zone of claystone down to the upper part of the top heading was confirmed by supplementary engineering geological survey. Layers of heavily weathered, tectonically faulted claystone were documented in the upper part of the top heading. Their thickness increased to ca 2.0m during the last top heading excavation action before the collapse. Concentrated inflow of ground water was recorded approximately in the surroundings of the borehole for an IBO needle, at the 13 o'clock position. The more significant concentrated inflow of ground water through the claystone massif resulted from the occurrence of a loose zone in the surroundings of the tectonic failure. Subsequent loosening of the disturbed claystone, frequent spilling of fragments and formation of overbreaks happened due to more significant weathering. The subsequent destruction of the massif was caused by the effect of the flow and pressure of ground water and its piping effects.

The ground environment under the collapse was stabilised by underpinning of the mass fill concrete and strengthening the collapse body for subsequent safe restoration of the excavation of the collapsed tunnel tube. The alternative of jet grouting (JG) from the terrain surface was selected from the technical point of view and was subsequently elaborated. In the first step, a concrete structure (a retaining wall) was carried out at the top heading front end before realising the jet grouting. It stabilised

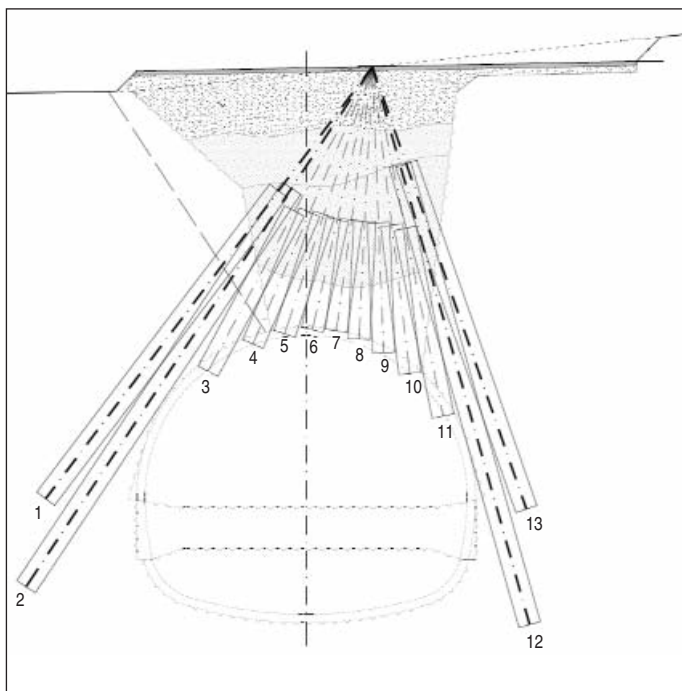
Obr. 3 Trysková injektáž z povrchu terénu  
Fig. 3 Jet grouting from the terrain surface

the front end during the realisation of the JG from the terrain surface. The concrete retaining wall in addition prevented contingent leaking of the jet grouting mixture into the mined tunnel profile. The massive retaining wall was carried out by casting concrete in stages, with recesses toward the excavation face (see Fig. 2). The second step of the stabilisation of the area being rehabilitated lied in the JG. A concrete working platform was carried out on the terrain surface above the collapse area. A fan of JG columns with the minimal diameter of 800mm was subsequently carried out from the platform (see Fig. 3). The JG columns 8.0–10m long, spaced at 0.65m intervals, are designed in the longitudinal direction. In the tunnel cross-section, the JG forms an A-shaped fan. Such the solution transmits the load acting on the mass concrete filling the crater to the sides, outside the tunnel, and the disturbed ground in the surroundings and above the tunnel tube is rehabilitated. The side JG columns are reinforced with steel tubes.

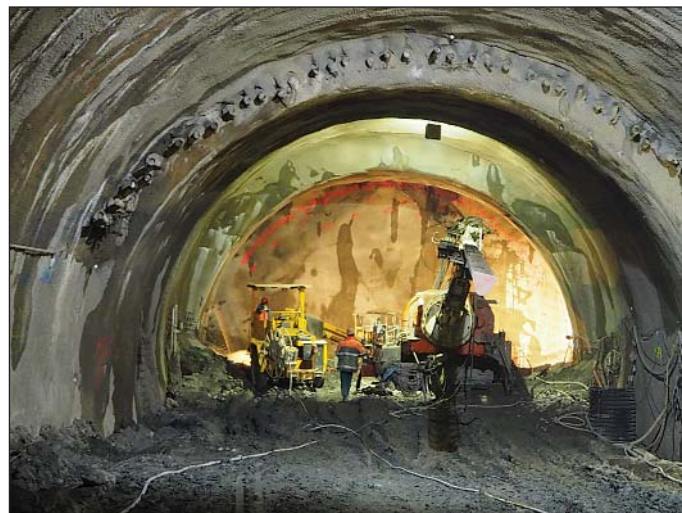
Obr. 4 Pohľad na mikropilótový dáždnik a vrtanie čelbových kotiev  
Fig. 4 A view of the canopy tube pre-support and drilling for anchors into excavation face

After many professional discussions and testing various measures directly on site, the application of glass fibre reinforced plastic anchors inserted into 150mm-diameter boreholes into the excavation face and subsequently filled with cement grout turned out to be most effective. The excavation face was stabilised by 70 glass fibre reinforced plastic anchors 16m long. In this way the ground material ahead of the excavation face was partially reinforced. Nevertheless, the anchors installed ahead of the excavation face still failed to prevent falling of the ground from the top heading vault. The originally designed IBO umbrella did not acquit itself. For that reason it was replaced with pressure-grouted canopy tube pre-support. The pre-support consisted of 40 pieces of 12m-long tubes grouted with a cement mixture (see Fig. 4). The tunnel drainage was provided by three 40m long horizontal drainage boreholes. The

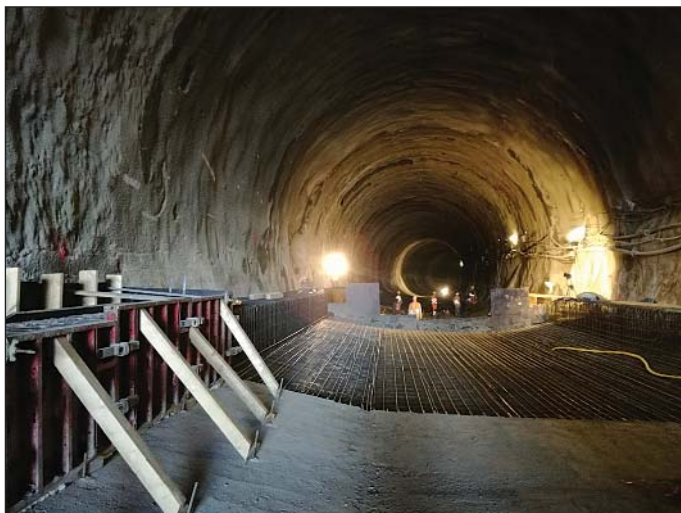
Obr. 5 Realizácia spodnej klenby tunela  
Fig. 5 Realisation of tunnel invert

V týchto úsekoch bola použitá prehĺbená spodná klenba, kde navýšenie objemu betónu hlbokaj spodnej klenby oproti spodnej klenbe bolo  $71,5 \text{ m}^3/\text{blok}$  (obr. 5). Sekundárne ostenie spodnej klenby je zo železobetónu triedy C25/30- $\text{XC3}$  –  $\text{Cl } 0,20$  –  $\text{D}_{\text{max}} 16$  – S4. Objem betónu na jeden blok je cca  $185 \text{ m}^3$ . Celkový objem betónu spodnej klenby v razenej časti tunela je  $10\,014 \text{ m}^3$  na jednu tunelovú rúru.

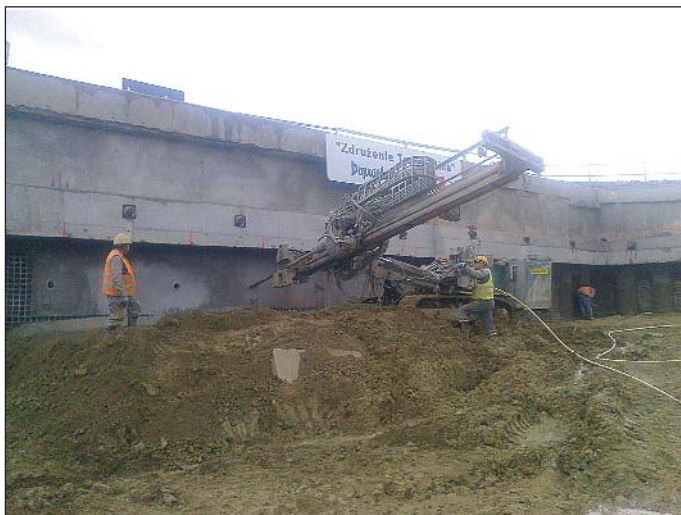
Obr. 3 Osadzovanie zemných klyncov medzi mikropilótami nad čelbou južnej tunelovej rúry

Fig. 3 Installation of soil nails between micropiles above the southern tunnel tube excavation face

The large-diameter piles in the areas of the excavation face of the southern tunnel tube were replaced with micropiles (see Fig. 2), the holes for which were drilled at 600mm intervals. Soil neils 22mm in dia and 4m long were subsequently installed in the area between the micropiles (see Fig. 3).

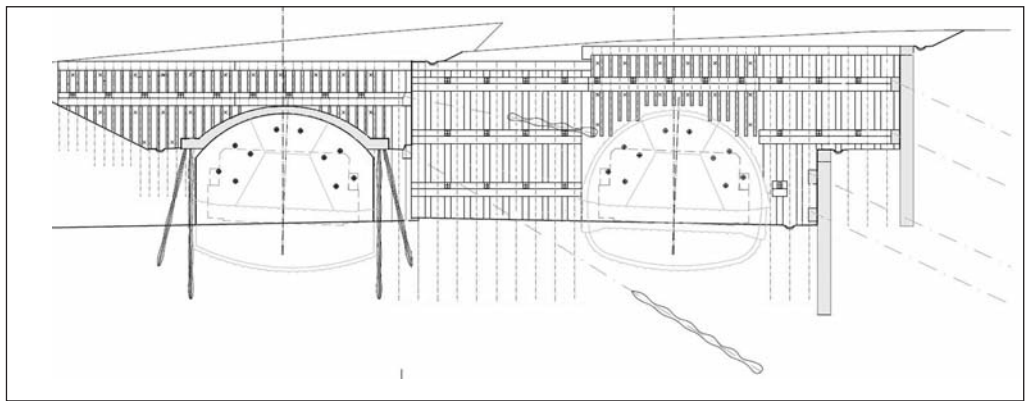
Obr. 2 Výrez z projektovej dokumentácie – pohľad na zabezpečenú portálovú stenu  
Fig. 2 Cutout from design documentation – a view of stabilised portal wall

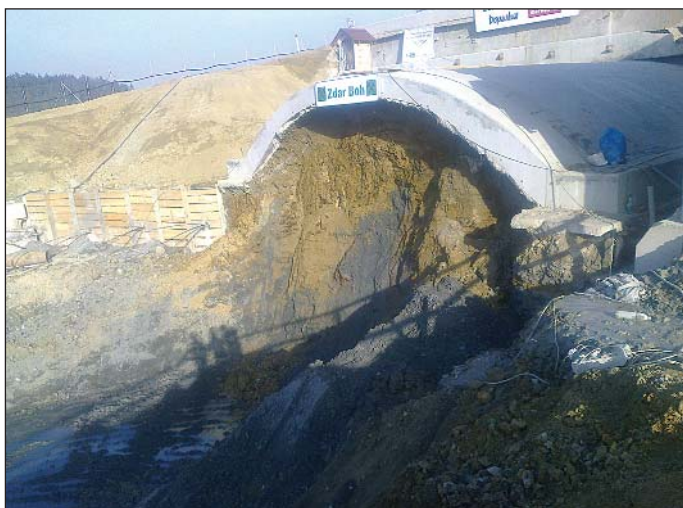
Obr. 4 Ochranná železobetónová klenba „korytnačka“  
Fig. 4 Protective reinforced concrete vault, “the tortoise shell”

A protective reinforced concrete vault, built using the method known in the practice as the “tortoise shell method”, was designed for reducing the volume of excavation at the base of the landslide (see Fig. 4). Four rows of micropiles were carried out in the area of the portal for the excavation of the left-hand tunnel tube, two rows on either side of the tunnel tube centre line. The micropiles were used as the foundation of the “tortoise shell” and as the bracing during the excavation of the left-hand tunnel tube. The centre-to-centre spacing of the micropiles amounted to 0.6m. The outer micropiles were inclined 13° from vertical, off the profile. The micropiles were subsequently grouted throughout the length, in 0.5m stages. After the required strength of the grout had been achieved, the 500–700mm thick vault was carried out using reinforced concrete grade C25/30 XA1,  $D_{max} = 16\text{mm}$ . The length of the tortoise shell amounted to 12.5m.

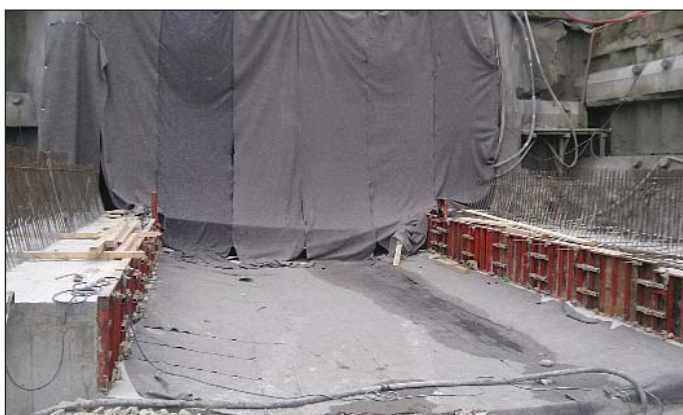
Obr. 5 Pohľad na spodnú klenbu hĺbeného tunela na západnom portáli  
Fig. 5 A view of the invert of the cut-and-cover tunnel at the western portal

Hrúbka ostenie tunela sa zväčšila na min. 0,60 m, a hrúbka spodnej klenby sa zväčšila na 1,0 m. Trieda betónu sa nezmenila.

A change in the thickness of the upper vault lining structure and a change in the foundation of the cut-and-cover tunnels from a flat foundation base to an increased-thickness invert was necessary as a result of the actually encountered geological conditions and the results of geotechnical monitoring of the western portal.
