REKONSTRUKCE TĚŠNOVSKÉHO AUTOMOBILOVÉHO TUNELU V ROCE 2002

THE TĚŠNOV ROAD TUNNEL RECONSTRUCTION IN 2002

ING. JIŘÍ ŠTEFAN, ELTODO DOPRAVNÍ SYSTÉMY, s. r. o.

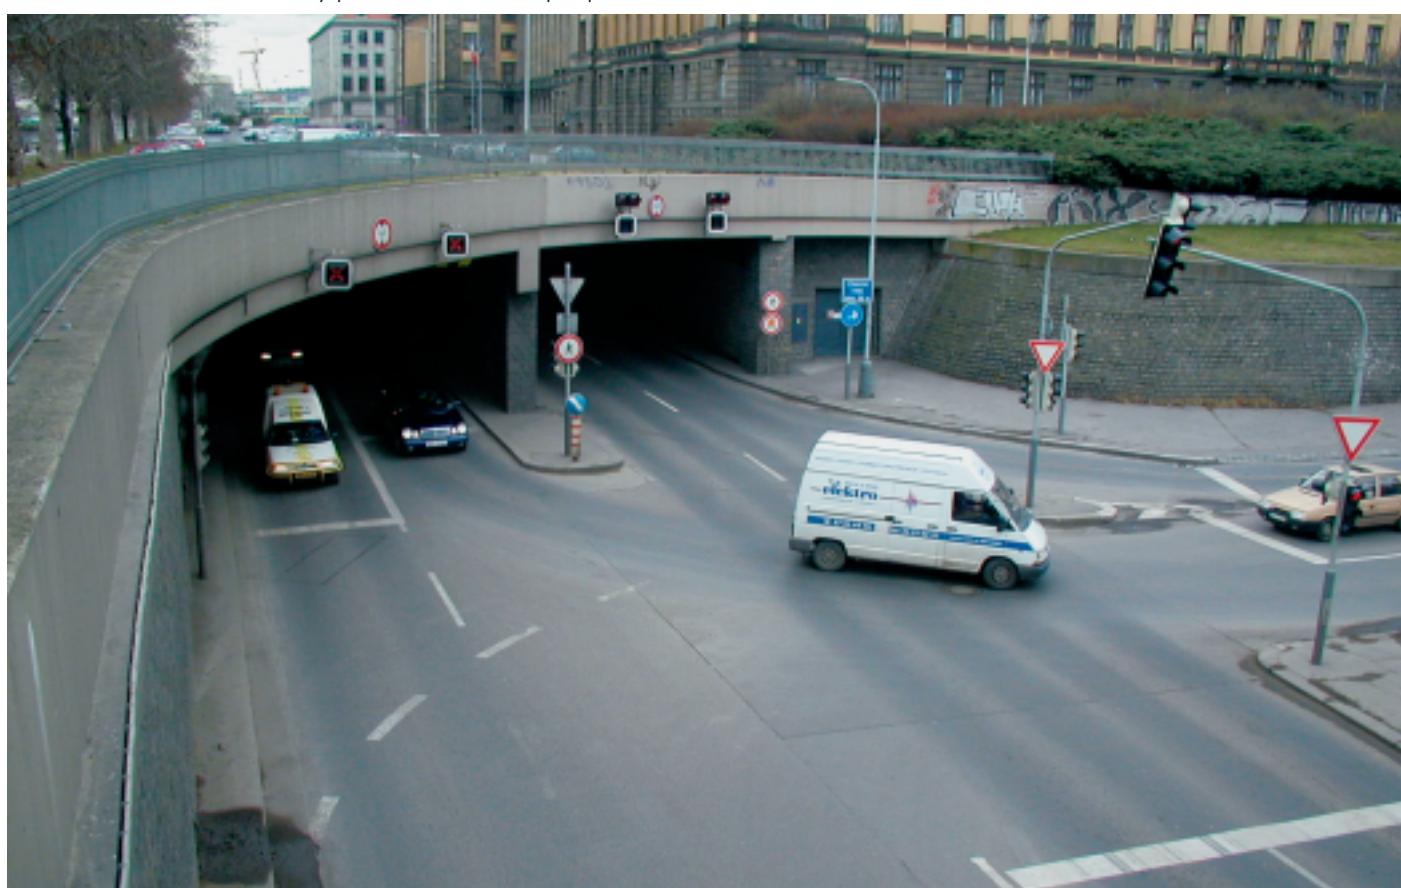
Obr. 1 Vjezd do Těšnovského tunelu z nábřeží Ludvíka Svobody
Fig. 1 The entrance to the Těšnov tunnel from the Ludvík Svoboda Embankment

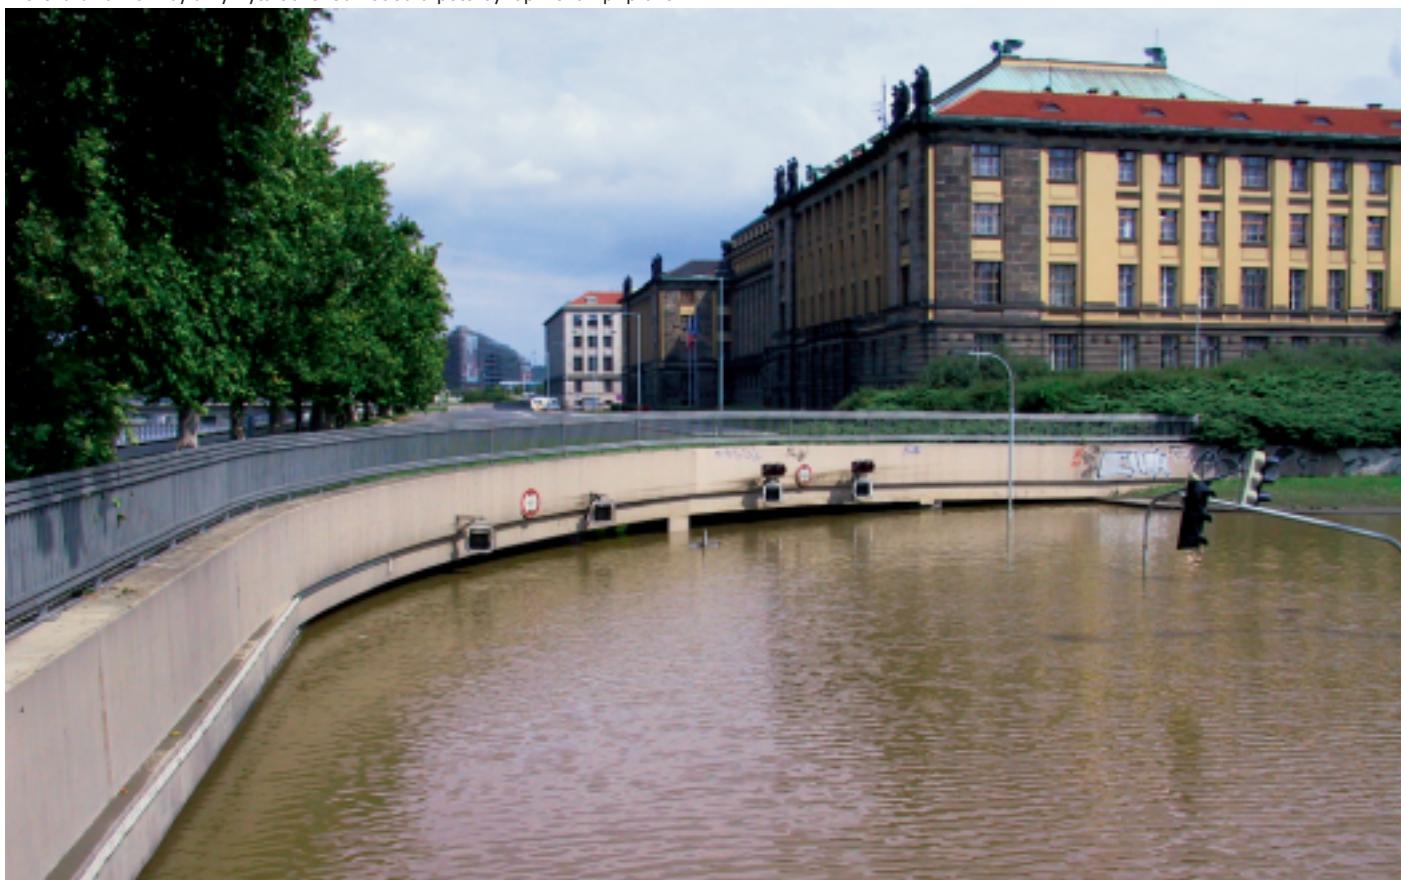
Zúčastnil jsem se 12. srpna kontrolního dne na obnově Letenského tunelu a při pohledu z Letenské pláně na mohutnou Vltavu nás začaly napadat nejistoty. Předpověď průtoku Vltavy Prahou, kterou jsme stále s napětím sledovali, sice tehdy byla ještě poměrně optimistická, ale události vzaly rychlý spád a již za 24 hodin, v úterý 13. srpna byl tunel zaplaven a vodní hladina se zastavila asi půl metru pod stropem tunelu. Postup vody byl tak rychlý, že se podařilo stihnout pouze vypnout napájení veškeré technologie a dveře narychlou utěsnit montážní pěnou. Obr. 2 – snímek zatopeného Těšnovského automobilového tunelu – byl pořízen ve středu 14. srpna 2002, a to prakticky ze stejného místa jako předcházející obr. 1. Jak je na něm vidět, byla zaplavena téměř celá technologie tunelu.

I was present at a site meeting held on 12 August regarding the refurbishment of the Letná tunnel. When we saw the mighty flow of the Vltava River, watching it from the Letná Plain, we were filled with doubt. We anxiously followed the forecast of the Vltava flow through Prague. The forecast was still relatively optimistic at that time, but events moved quickly and after 24 hours (on Tuesday the 13th August) the tunnel was flooded and the water surface levelled at about half a meter under the tunnel ceiling. The progress of the water rising was so fast that the operator managed only to disconnect the power supply of all equipment, and to seal doors with assembly foam. The picture shown in Fig. 2 - the flooded Těšnov road tunnel – was taken on Wednesday the 14th August 2003, practically from the same spot as the previous picture shown in Fig. 1. It can be seen that nearly all tunnel equipment was flooded.

Obr. 2 Zaplavený Těšnovský tunel (autorka snímku Ing. Věra Šottová)
Fig. 2 The flooded Těšnov tunnel (author of the picture Ing. Věra Šottová)

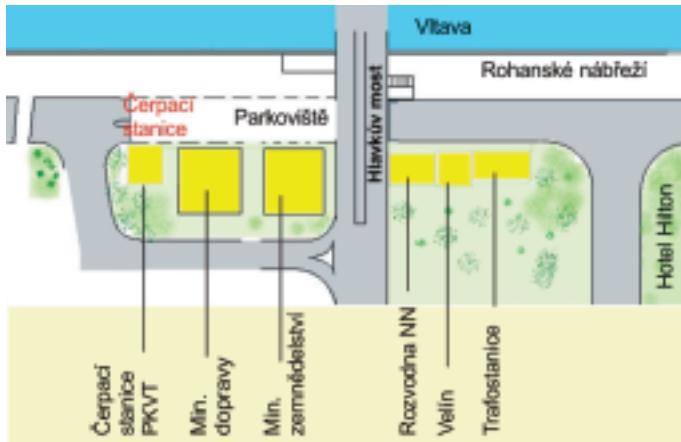
Voda začala ve čtvrtek 15. srpna znatelně opadávat a v pátek ve 20.00 hod. již bylo možno zahájit přípravy k čerpání vody z tunelu, protože hladina řeky Vltavy již nebyla spojena s hladinou v tunelu. Jako nevhodnější místo k postavení čerpadel byl vybrán prostor na konci parkoviště před budovou Ministerstva dopravy a spojů, nad čerpací stanicí PKVT, kde je také nejnižší místo celé oblasti a kam se voda stahuje přirozenou cestou. V celé oblasti byl vypnuto elektrický proud, ale čerpací souprava byla vybavena vlastním agregátem o výkonu 110 kW, který stačil pohánět až čtyři 10 kW ponorná čerpadla o výkonu 25 litrů za sec. Jejich umístění je patrné z následujícího obr. 3.

The water level started subsiding visibly on Thursday the 15th August, and by Friday 8 p.m. it was already possible to start the preparation of pumping water from the tunnel as the water surface in the Vltava River was no more connected with the water surface inside the tunnel. The end of a car parking in front of the Ministry of transport (above the PWW's pumping station) was chosen as the most suitable location for the installation of pumps. This location is the lowest place of the whole area and water collects here naturally. The power was disconnected within the whole area, but the pump was equipped with its own generator with an output of 110 kW sufficient to power up to four 10 kW submersible pumps each with an output of 25 litres per second. The position of the pumps is shown in Fig. 3.

Obr. 3 Náčrtka situace u Těšnovského tunelu

Fig. 3 The Těšnov tunnel plan

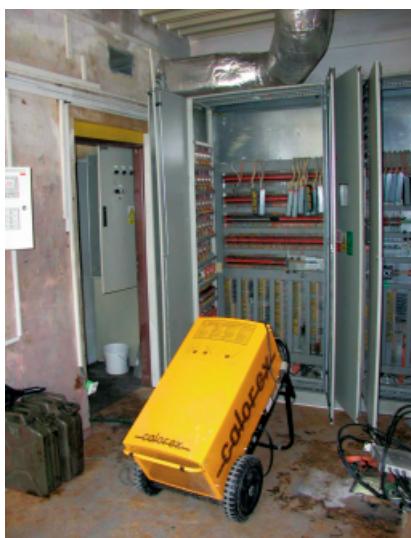
Pro opravy by velmi důležitý vlastní zdroj elektrické energie. Použili jsme postupně několik agregátů o výkonech 35 až 80 kW, které nám zajistily nejnutnější osvětlení tunelu, osvětlení velínu a energii pro činnost vysoušečí technologie. Tyto agregáty umístěné v kontejnerech pracovaly při minimální údržbě po celou dobu bez závad. Dále se ukázal opravdu účinným nástrojem elektrický vysoušeč, v činnosti je zachycen na obr. 4.

The independent power source was extremely important for the repairs. We used several sets of generators in succession with outputs of 35 to 80 kW which supplied the necessary lighting in the tunnel and control centre and provided power for drying equipment. The generators were installed in containers. They worked for the entire time with minimal maintenance without defects. The electric dryer also proved to be a very efficient tool. Its operation is shown in Fig. 4.

Obr. 4 Vysoušení prostoru velínu po prvotní očistě

Fig. 4 Drying the interior of the control centre after the initial clean-up

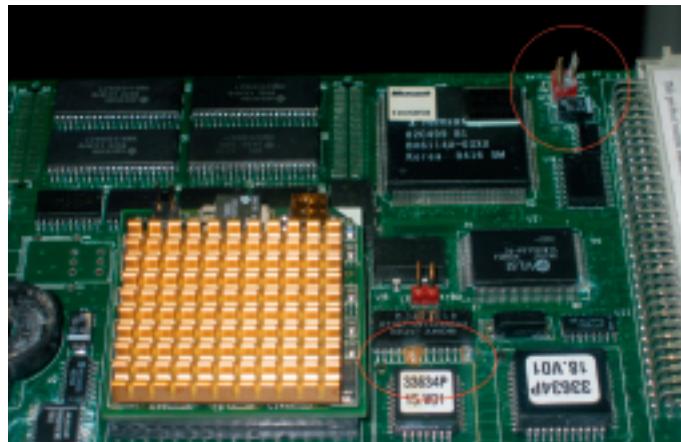
jíž uvedl, před zaplavením tunelu byla veškerá technologie vypnuta od napájení. V některých přístrojích však zůstaly baterie zálohující napájení speciálních okruhů (hodiny reálného času, polovodičové paměti apod.). Na obrázku 6 je detail základní desky zařízení pro detekci zastavených vozidel (Autoscope), které je použito v Těšnovském tunelu.

Červený kruh upravo nahoře značí elektrochemickou korozí na svorkách pro

připojení zálohované baterie, červená elipsa v dolní části snímku ukazuje na vývody od integrovaného obvodu přerušené vlivem právě této elektrochemické koruze. Ačkoliv je základní deska jinak ve vizuálně velmi dobrém stavu, nedá se použít ani spolehlivě opravit.

Another phenomenon we encountered was electrochemical corrosion. As I have already mentioned, all equipment was disconnected from the power source before the tunnel flooding. Batteries serving as standby sources for special circuits (real-time clock, semiconductor memory etc.) were not, however, removed from some apparatuses. The mounting base of the equipment detecting standing vehicles (Autoscope), which is used in the Těšnov tunnel, is shown in Fig. 6. The red circle in the top right corner indicates the electrochemical corrosion on clips connecting standby batteries. The red ellipse at the bottom of the picture indicates terminals of the integrated circuit interrupted due to the electrochemical corrosion. Despite the fact that the mounting base is otherwise in visually very good condition, it can be neither used nor reliably repaired.

Obr. 6 Elektrochemická koruze na deskách elektroniky

Fig. 6 Electrochemical corrosion on electronics boards

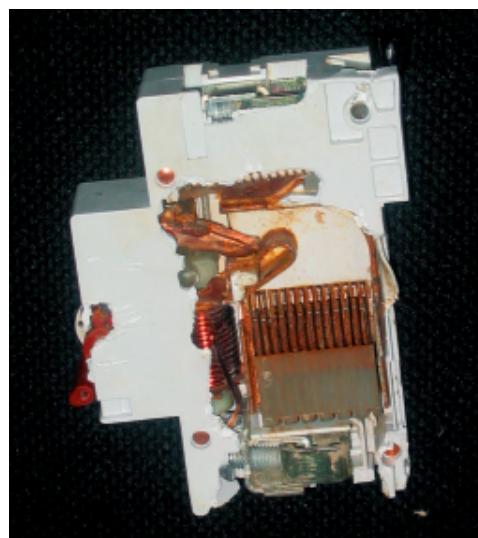
Snímek odkrytého jističe na obr. 5 se váže k otázce, která vznikla při čištění zatopené technologie. Někteří pracovníci tehdy zastávali názor, že i jistič stáčí několikrát důkladně propláchnout tlakovou vodou, závěrečné prostříkání provedet konzervačním prostředkem a jistič bude bezvadně fungovat. Poté, co jsme jeden takto ošetřený jistič rozebrali, tak se všichni přítomní přiklonili k názoru, že pro zachování správné funkce tohoto prvku je nutno všechny tyto zaplavené prvky nahradit novými. Konstrukce jističe je poměrně složitá a dostatečně vyčíslení mechanizmu není možno realizovat bez rozebrání zařízení. Rovněž byly vyměněny všechny stykače a elektromechanická relé i s paticemi.

The picture of the open breaker shown in Fig. 5 is connected with the question that emerged in the process of cleaning the flooded equipment. Some people held the opinion that it was sufficient to wash the breakers thoroughly several times with pressurised water, eventually to spray them with a conservation compound, and the breaker would work perfectly. When we dismantled one of the breakers treated with the above-mentioned method, all the people present agreed that all the flooded elements had to be replaced with new ones if the proper functioning of the system was to be maintained. The structure of the breaker is relatively complex, and the mechanism cannot be cleaned sufficiently without dismantling the equipment. All contactors and electromechanical relays including the bases were also replaced.

Obr. 5 Vnitřek zatopeného jističe

Fig. 5 The interior of the flooded breaker
