# POZNATKY Z ADAPTÁCIE RAZENIA NA IN SITU PODMIENKY V TUNELI OVČIARSKO

## LESSONS LEARNED FROM THE ADAPTATION OF EXCAVATION TO THE IN-SITU CONDITIONS IN OVČIARSKO TUNNEL

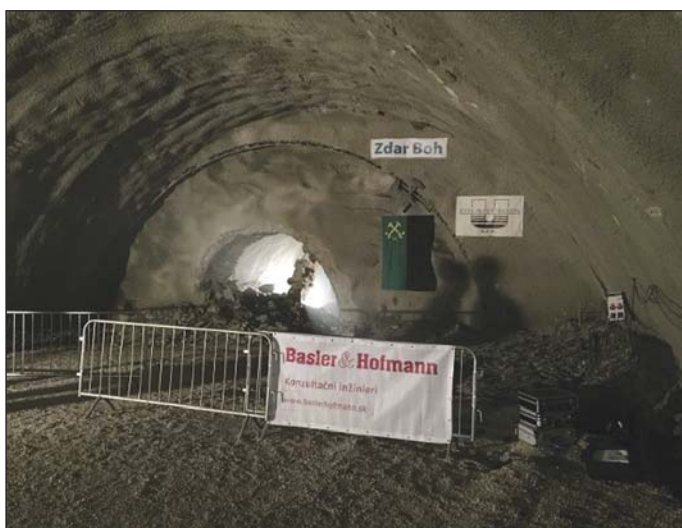
Obr. 1 Prerážka severnej tunelovej rúry  
Fig. 1 Northern tunnel tube breakthrough

Razenie tunela Ovčiarsko začalo v STR 22. 7. 2014 a v JTR 7. 8. 2014. Oficiálna prerážka STR (obr. 1) bola realizovaná dňa 28. 4. 2016 v staničení trasy 2,04058 km a tunelovom metri (TM) 1751,58 m od západného portálu (ZP). Prerážka JTR bola

The excavation of the Ovčiarsko tunnel commenced in the NTT on 22nd July 2014 and in the STT on 7th August 2014. The official NTT breakthrough (see Fig. 1) took place on 28th April 2016 at the motorway chainage km 2.04058 and the tunnel chainage meter 1751.58 (measured from the western portal). The STT breakthrough was realised on 12th July 2016 at the motorway chainage km 2.22969 and the tunnel chainage meter 1967.69 (measured from the western portal).

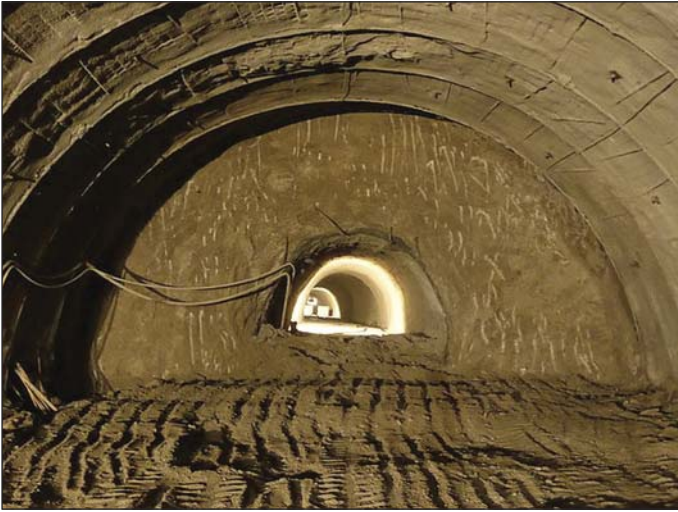
Obr. 2 Charakteristická čelba súľovských zlepcov, kde sa realizovali najdlhšie zábery v kalote  
 Fig. 2 Characteristic excavation face in Súľov conglomerates, where the longest excavation advance rounds were realised at the top heading

Vystrojovacia trieda 4/2 bola v STR a JTR použitá v úseku najpriaznivejších inžinierskogeologických charakteristík horninového masívu, kde horninový masív bol tvorený prevažne súľovskými zlepcami a súvrstviem zlepcov, pieskovcov a siltovcov. Horniny vykazovali vysokú pevnosť (zlepence až 50–90 MPa), nízky stupeň zvetrania, nízky stupeň rozpukanosti (RQD lokálne až 100 %) a zároveň priaznivú orientáciu plôch nespojitosti voči smeru razenia (obr. 2). Takéto geologické podmienky umožňovali realizovať najdlhšie postupy na kalote (do 2,2 m) vo vystrojovacej triede 4/2.

Excavation support class 4/2 was used in both the NTT and STT in the section of the most unfavourable engineering geological characteristics of the rock mass, where the rock massif was formed mainly by Súľov conglomerates and a conglomerate, sandstone and siltstone formation. The rocks exhibited high strengths (conglomerates up to 50–90 MPa), low degree of weathering, low degree of fracturing (RQD locally up to 100%) and, at the same time, favourable orientation of discontinuity surfaces relative to the direction of the tunnel excavation (see Fig. 2). Such the geological conditions allowed for the realisation of the longest advance rounds at the top heading (up to 2.2m) in excavation support class 4/2.

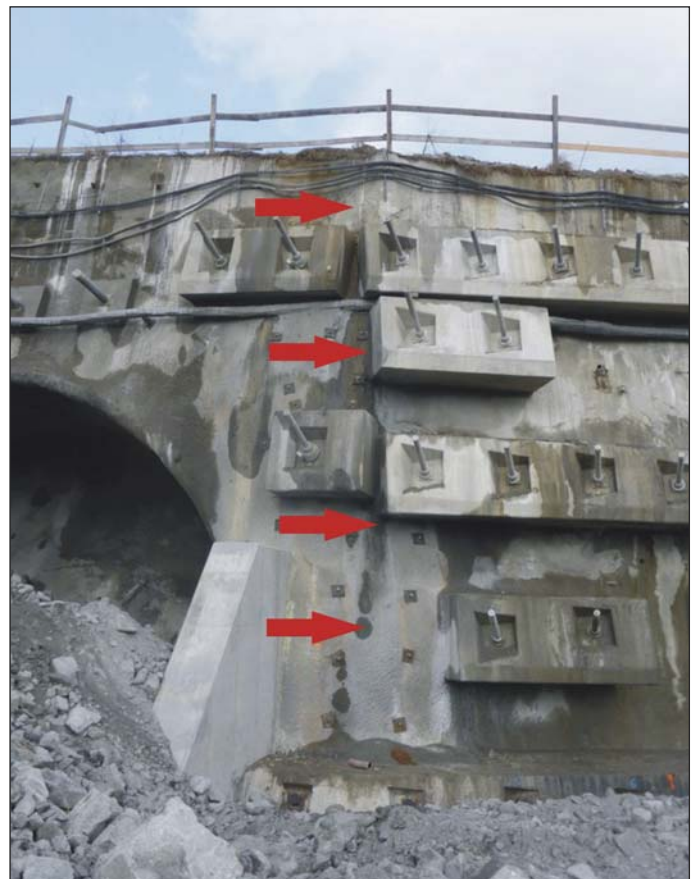
Na VP boli práce na výstavbe začaté razením JTR v auguste 2014. Po vyrazení 4,95 m v kalote došlo k vzniku trhlin na portálovej stene a sadnutiu celej portálovej steny o cca 5 cm vo vertikálnom smere. Z tohto dôvodu stavebný dozor (SD) a projektant zastavili práce na JTR a zároveň na celom VP tunela Ovčiarsko.

The work from the eastern portal started by the excavation of the STT in August 2014. After completing the excavation of 4.95m at the top heading, cracks developed in the portal wall and the whole portal wall settled vertically about 5cm. For that reason the project owner's supervising engineer and the designer stopped the work on the STT and, at the same time, on the whole eastern portal of the Ovčiarsko tunnel.

Obr. 3 Miesto porušenia portálovej steny (šípky ukazujú na miesto praskliny)  
 Fig. 3 Portal wall break location (arrows indicate the crack location)

Postup prác sanácie portálu bol nasledovný (obr. 3, 4):

- realizácia šiestich subhorizontálnych odvodňovacích vrtov dĺžky 120 m;
- podchytenie portálovej steny kotevnými prahmi (C30/37 + B500B) založenými na mikropilótach 89/10 dĺ. 9 m 35 ks;
- v mieste vertikálnej praskliny: striekaný betón (SB) C25/30, osadené kari siete 8x150 a samozavrtné svorníky typu IBO R32 dĺ. 8 m (raster 1x1 m);
- prekotvenie lanovými kotvami 14 ks, dĺ. 25 m;
- nad hranou portálu cementová injektáž.

The following process of the portal stabilisation was applied (see Figures 3 and 4):

- clearing the existing drainage boreholes;
- carrying out six 120m long sub-horizontal drainage boreholes;
- underpinning the portal wall with anchoring beams (C30/37 + B500B) founded on 35 pieces of 9m long micropiles 89/10;
- in the location of the vertical crack: shotcrete C25/30 reinforced with KARI welded mesh 8x150mm and 8m long self-drilling rock bolts IBO R32 (1 x 1m grid);
- new anchoring with 14 pieces of 25m long cable anchors;
- cement grouting above the portal edge.

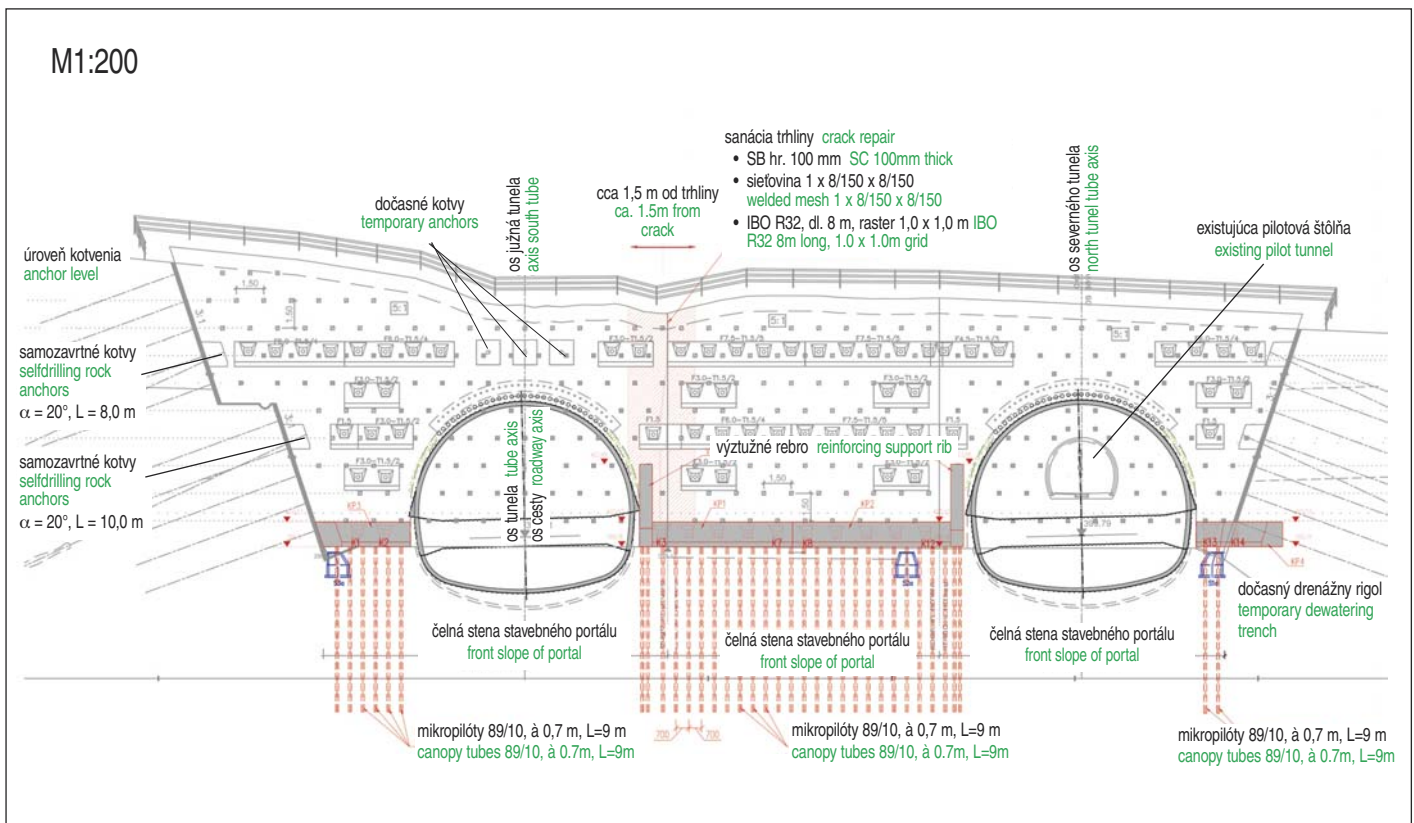
Obr. 4 Pohľad na portálovú stenu s dodatočnými sanačnými opatreniami  
Fig. 4 A view of the portal wall with the additional stabilisation measures

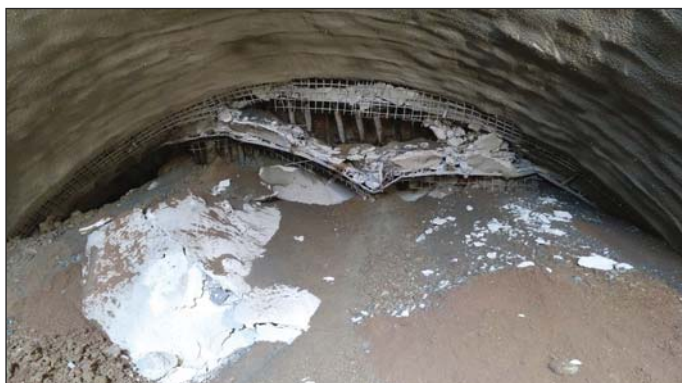
V dôsledku veľmi nepriaznivých inžinierskogeologických charakteristík horninového masívu pri nadväzujúcom razení JTR od VP, kde horniny boli až charakteru zeminy, došlo dňa 7. 8. 2015 k vytlačeniu čelby kaloty do tunelovej rúry. Pri otvárani zaberu zároveň došlo k prelomeniu rúr ochranného mikropilótového

Obr. 5 Vytlačenie horninového materiálu do tunelovej rúry s deformáciou rúr mikropilótového dáždnika a priehradových nosníkov  
Fig. 5 Ground material extrusion into the tunnel tube; deformation of canopy tubes and lattice girders

As a result of the very unfavourable engineering geological characteristics of the rock mass during the course of the subsequent excavation of the STT from the eastern portal, where the ground even had the character of soils, the top heading excavation face was extruded into the tunnel tube on 7<sup>th</sup> August 2015. The protective canopy tube pre-support and steel ribs broke down and a “daylight” collapse of the ground material developed (see Fig. 5) when the new round of excavation was being opened

dáždnika (MPD), prelomeniu nosníkov a „vykomínovaní“ horninového materiálu až na povrch (obr. 5).

The following work procedure was chosen with respect to the need for the immediate stabilisation the collapsed material:

- covering the complete surface of the collapse cone with shotcrete;
- installing two layers of welded mesh 8x8x150;
- applying shotcrete to the upper part of the top heading excavation face;
- installing 8m long IBO R32 self-drilling rock bolts on a 1.5x1.5m grid and subsequently filling the boreholes with cement grout.

Z dôvodu potreby okamžitej stabilizácie vypadnutého materiálu bol zvolený nasledujúci postup prác:

- celoplošný nástrek závalového kužeľa SB;
- osadenie dvoch vrstiev ocelových sietí 8x8x150;
- nástrek SB do hornej časti čelby kaloty;
- osadenie čelbových samozávrtných svorníkov IBO R32 dĺžky 8 m v rastru 1,5x1,5 m a ich následné zacementovanie.

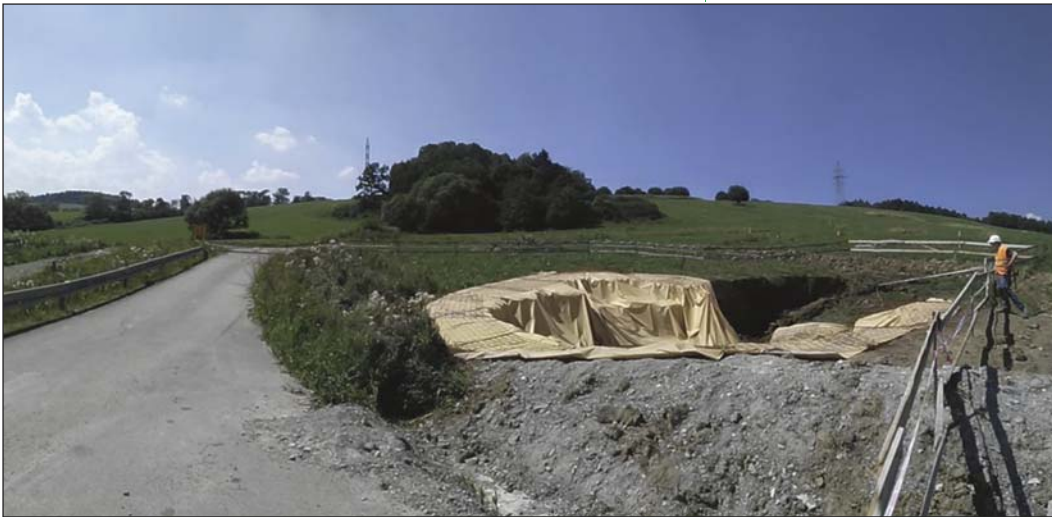
Obr. 6 Povrchová depresia vzniknutá prepadosť terénu  
Fig. 6 Surface depression developed by sinking of terrain

Prvá fáza projektu bola opísaná vyššie, kde jej cieľom bola okamžitá stabilizácia vypadnutého horninového materiálu. Druhá fáza sa týkala samotnej realizácie zmáhania prepadosť terénu v tunelovej rúre (obr. 6, 7 a 8).

- navrhovanie sklolaminátových svorníkov dĺžky 16 m do čelby v počte 40 ks s únosnosťou 300 kN, prekotvenie po 10 m;
- navrhovanie dvojradového MPD priemeru 114,3 mm s hrúbkou steny 10 mm v počte 46 ks dĺžky 15 m;
- na podchytenie MPD boli zabudované dva nosníky 126/22/32, ktoré boli následne zastreikované SB spolu s ocelovými sietami;
- vyplnenie vzniknutej depresie na povrchu liatym betónom typu C16/20 v množstve zhruba 100 m<sup>3</sup>;
- technologická prestávka pre vytvrdenie betónu na povrchu.

inside the tunnel tube (see Figures 6, 7 and 8).

- drilling 40 holes into the excavation face for 16m long glassfibre reinforced plastic rock bolts with the load capacity of 300kN; repeated bolting after 10m;
- drilling holes for a double-row canopy tube pre-support with 46 pieces 15m long tubes 114.3mm in diameter and walls 10mm thick;
- two beams 126/22/32 were incorporated into the structure to underpin the canopy tubes; they were subsequently covered with shotcrete-

- filling the depression originated on the surface with about 100 m<sup>3</sup> of C16/20-grade poured concrete.

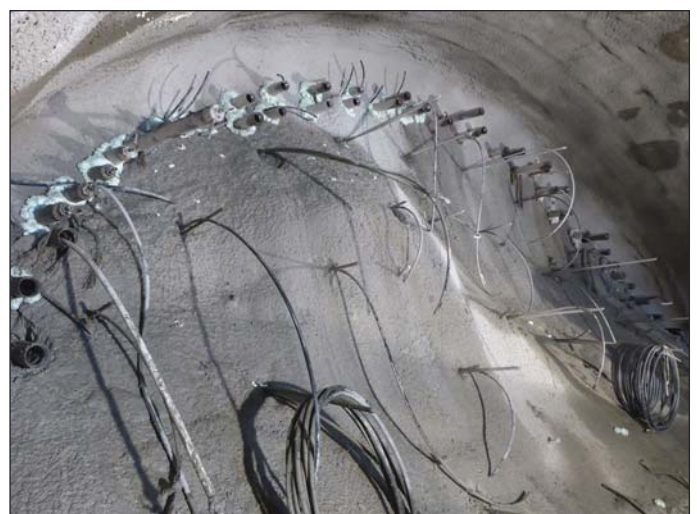
Obr. 7 Pohľad na zaistenú čelbu, sklolaminátové svorníky čelby, dvojradový mikropilotový dáždnik

Fig. 7 A view of the stabilised excavation face, glassfibre reinforced plastic rock bolts installed into the excavation face, the double-row canopy tube pre-support

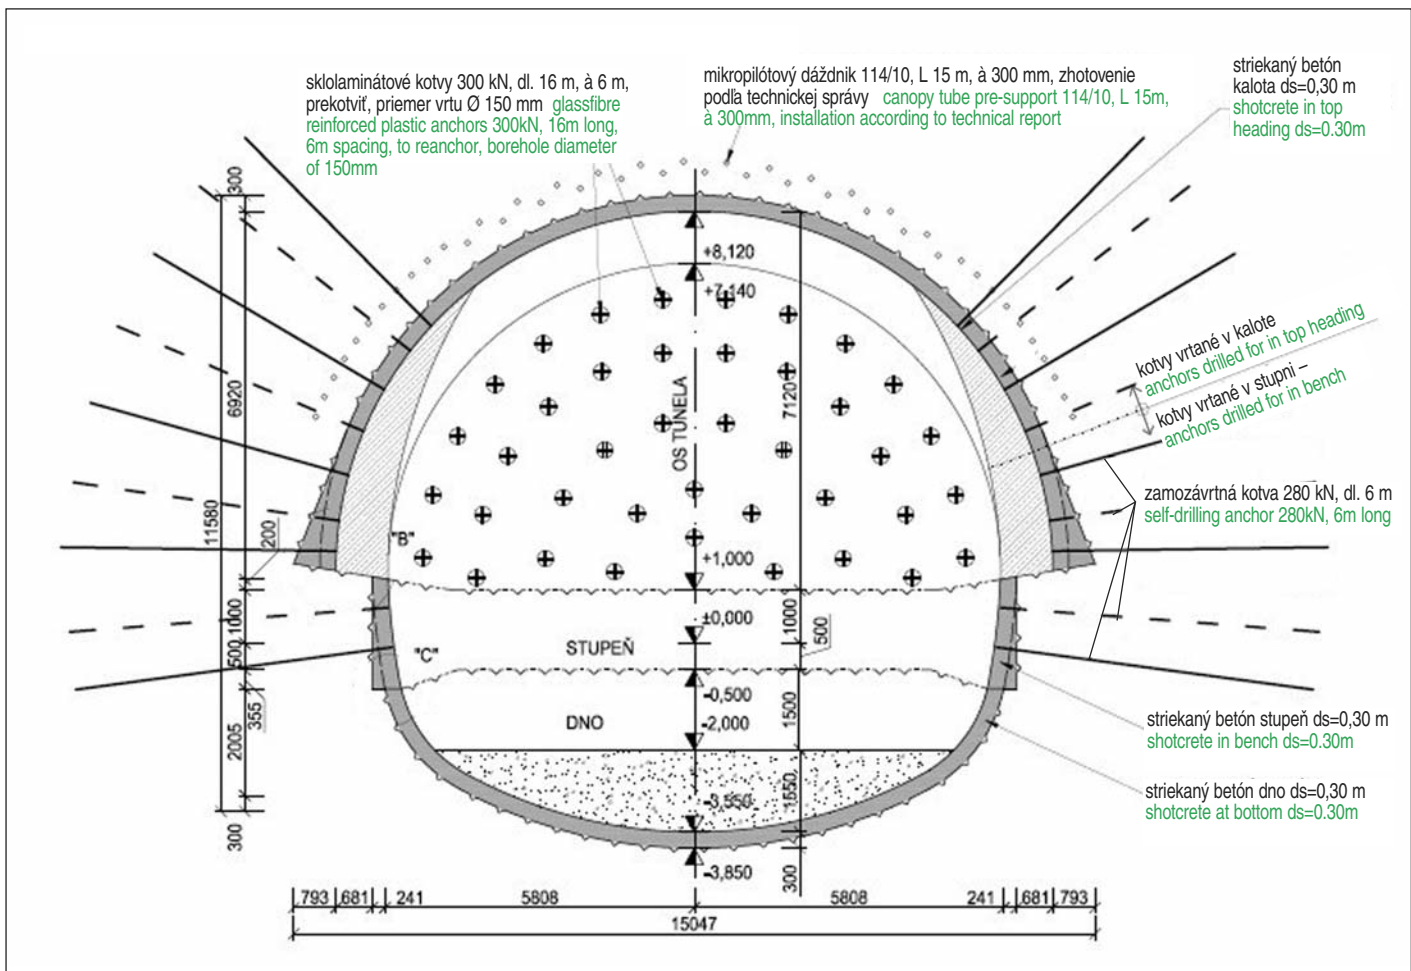
Obr. 8 Rez po uzavretí profilu VT 7MPZ

Fig. 8 Cross-section after closing the profile, excavation support class 7MPZ

Realizácia razenia pod MPD vo vstrojovacej triede (VT) 7MPZ bola s postupným členým výlomom čelby kaloty a okamžitým nástrekom SB. Hrúbka SB bola zvolená 0,3 m. Ako radiálne svorníky boli použité samozávrtné svorníky typu IBO R32/280kN dĺžky 6 m.

The excavation under the canopy tube pre-support was realised in excavation support class 7MPZ, with the top heading excavated sequentially and the excavation face immediately covered with shotcrete. The thickness of 0.3m was selected for the shotcrete. Self-drilling IBO R32/280kN rock bolts 6m long were used as radial bolts.

The excavation in excavation support class 7MPZ at the length of 19.14m was repeated twice, using the same procedure.
