PŘESTAVBA TUNELU BLANENSKÝ Č. 8/2 RECONSTRUCTION OF TUNNEL BLANENSKÝ NO. 8/2

As part of the reconstruction of the track section between the towns of Adamov and Blansko, the single-track tunnel Blanenský No. 8/2, mined between 1988 and 1992 using the ring method, was reconstructed. It was provided with a final lining made of reinforced concrete and cast iron segments with a brick packing between the excavation and the lining. The composition of the tunnel lining proved insufficient waterproofing. In winter, icicles, icefalls and frost heaves were formed inside the tunnel; the operation of the railway line was not smooth and safe, which was one of the fundamental reasons for the proposal to reconstruct the tunnel. The design involved construction of completely new primary and secondary linings with intermediate waterproofing. The initial months were quite complicated for re-excavation and operations at the surface due to several adverse factors: (a) the operation of No. 1 siding during the works until the closure of that siding to traffic; (b) the stability of the excavation had to be secured for several months by a dry process sprayed concrete; (c) the decision to permit the blasti

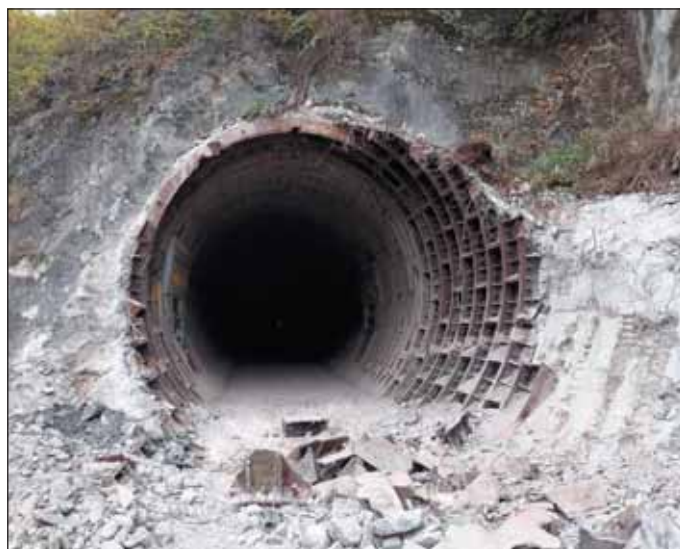
Obr. 2 Litinové a železobetonové tubingy, portál P1 (Adamov)
Fig. 2 Cast iron and reinforced concrete lining segments, P1 portal (Adamov)

Tunelová trouba raženého tunelu č. 8/2 byla v celé délce kruhového průřezu vystrojena montovaným ostěním se světelným průměrem 7,80 m, které bylo u obou koncových částí tunelu provedeno z litinových tubingů (typy Moskva a Leningrad, šířky 0,75 m, vždy osm kusů plus klenákový díl v každém prstenci, dovoz SSSR). Ve střední části bylo ostění provedeno ze železobetonových tubingů pravděpodobně již českého výrobce (obr. 2).

The tunnel tube of the mined tunnel No. 8/2 was lined along the entire length of the circular cross-section with a segmental lining with a finished diameter of 7.80m, which consisted of cast-iron segments (Moscow and Leningrad types, width of 0.75m, always eight pieces plus a key in each ring, USSR import) at both end parts of the tunnel. In the central part, the cladding consisted of reinforced concrete segments, probably already produced by a Czech manufacturer (Fig. 2).

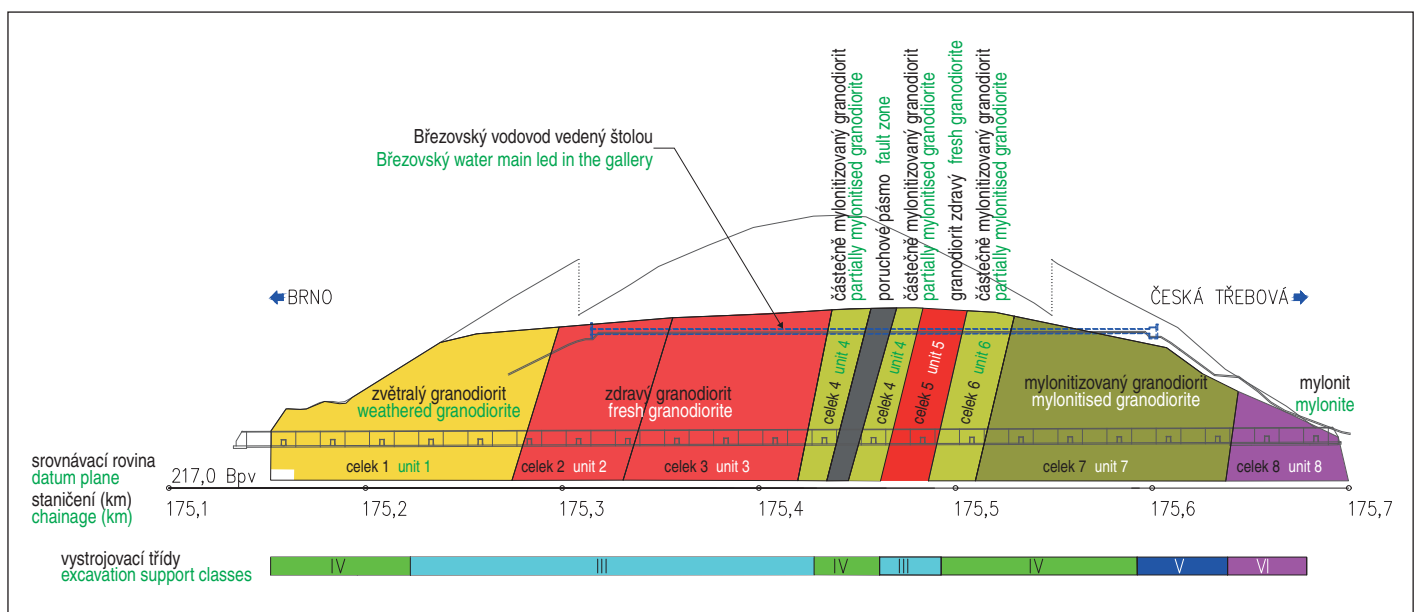
Obr. 5 Geologický profil, kvazi-homogenní celky
Fig. 5 Geological cross-section, quasi-homogeneous units

Na základě skutečně zjištěných inženýrskogeologických poměrů byla ražená část tunelu rozdělena na osm kvazihomogenních celků, které představují úseky tunelu, kde mají horniny podobné geotechnické vlastnosti (obr. 5).

Based on the actual engineering geological conditions, the mined part of the tunnel was divided into eight quasi-homogeneous units, which represent sections of the tunnel where the rocks have similar geotechnical properties (Fig. 5).

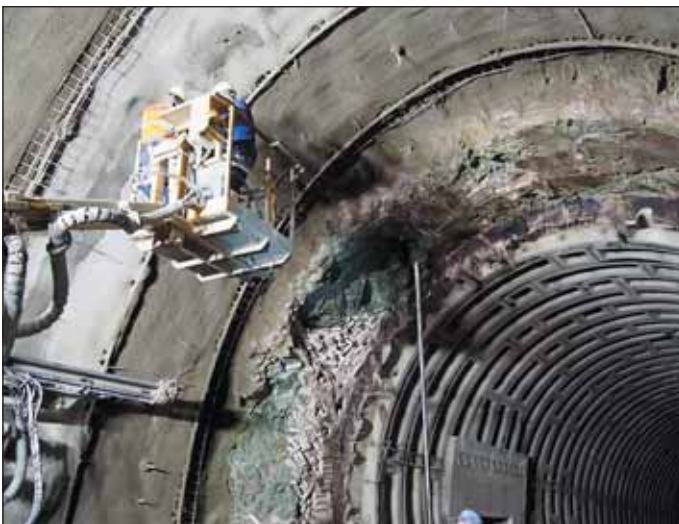
Obr. 6 Původní zakládká z cihel za montovaným ostěním ze žb. tubingů
Fig. 6 Original brick packing behind reinforced concrete segmental lining

Stávající tunel byl přerážen, tzn. zvětšován, přičemž na ražbu a primární ostění byly aplikovány principy Nové rakouské tunelovací metody. Jelikož se jednalo o přestavbu stávajícího tunelu s ostěním provedeným z betonových a litinových tubingů, musely být tyto prvky nejprve demontovány. Následně se přistoupilo k samotnému zvětšování profilu po obvodu výrubu, který byl tvořen převážně cihelnou zakládkou prolitou cementovou zálivkou (případně v kombinaci s bentonitem) a horninovým masivem (obr. 6).

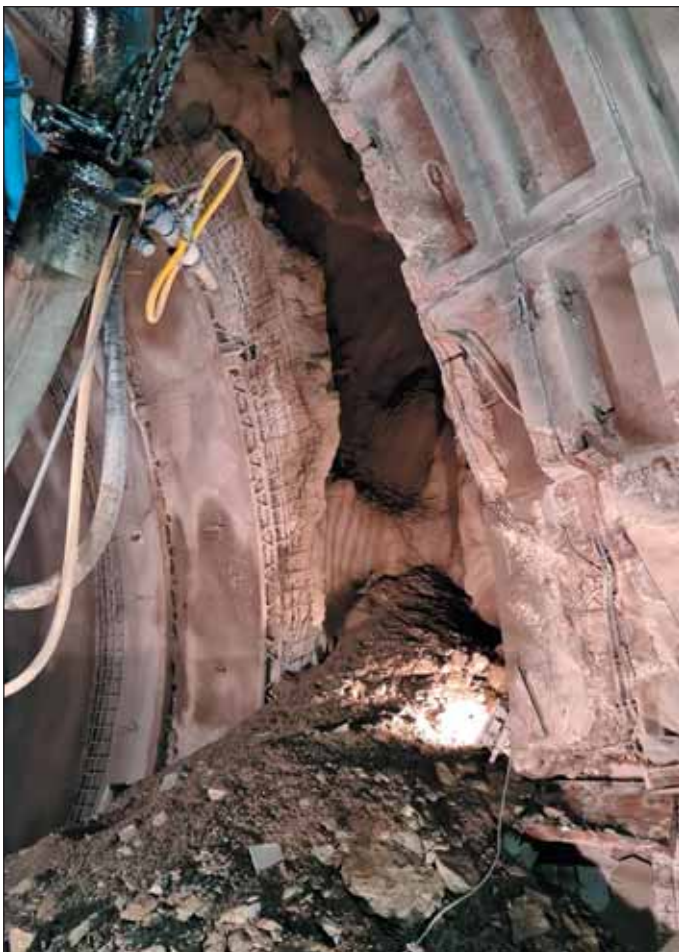
Obr. 7 Nadvýlom 17. 05. 2022
Fig. 7 Overbreak 17. 05. 2022

The already completed primary lining had to be demolished and replaced with a new one in a length of 10m, only on the left side and in the crown of the tunnel. The right-hand side of the primary lining was only reinforced by radial rockbolts. The left-hand side was completely reconstructed by connecting new BTX lattice girders in the top of the vault to the part of the frames left in place on the right side. This gave rise to a new primary lining of the entire left half of the profile, including tying to the rock face.

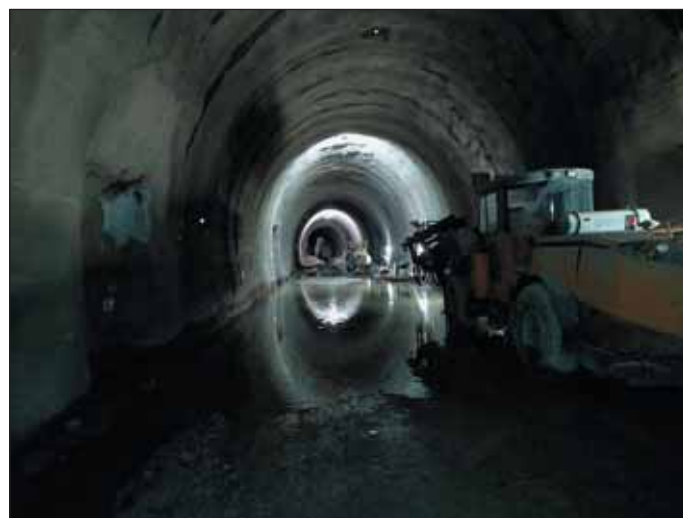
Obr. 9 Zatopený tunel po havárii Březovského vodovodu

Fig. 9 Water-glogged tunnel bottom after Březovský water main accident

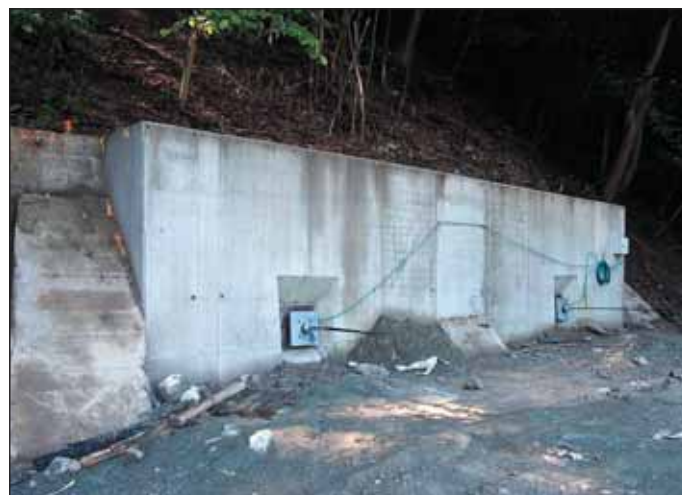
Obr. 10 Kotvený železobetonový práh nad blanenským portálem P2
Fig. 10 Anchored reinforced concrete block above Blansko portal P2

Svah nad blanenským portálem P2, tvořený hlinitokamenitými sedimenty s obsahem jílové frakce, vykazoval již během budování tunelu v letech 1988 až 1992 svahové deformace. Právě nad tímto svahem vede již zmíněný Březovský vodovod. O nestabilitě horninového masivu u blanenského portálu v oblasti porušených mylonitů se přesvědčili i tehdejší stavitelé tunelu. Během ražby průzkumné štolky ze strany blanenského portálu ji po několika desítkách metrů po závalu museli obejít novou štolou a napojit se do plánované trasy tunelu až cca 80 m od blanenského portálu. Projektant RDS chtěl předejít možným rizikům a komplikacím, souvisejícím s přeražbou tunelu a případnou aktivací svahových nestabilit, navrhl proto dodatečné zajištění svahu proti případnému sesuvu lanovými kotvami. Byly navrženy celkem dvě trvalé dvoupramenové kotvy o délkách 45 m s kořeny dlouhými 15 m, upnutými v pevnější hornině mimo porušené mylonity. Kotvy byly upnuty v hlavách přes nový betonový kotevní práh o šířce 8,6 m, výšce 3,5 m a tloušťce 1,0 m (obr. 10) pevnostní třídy betonu C30/37. Kotvy byly předepnuty silou pouze několika tun (20 kN) s tím, že by se v případě aktivace sesuvu samy dopnuly. Před konečným upnutím hlav byly testovány s postupným napínáním po dobu 60 min až na hodnotu zkušební síly cca 200 kN. Kotevní práh byl proveden jako spřažený se stávajícím betonovým prahem vybudovaným mezi lety 1988 a 1992 jako opatření proti vzniku sesuvu. Součástí vybudování kotevního prahu byla také dočasná nájezdová rampa o šířce 4,0 m. Ta vedla v extrémně prudkém svahu nad portál tunelu a byla ukončená pracovní plochou o rozměrech 7,0 m × 10,0 m ve výšce cca 6 m nad portálem tunelu.

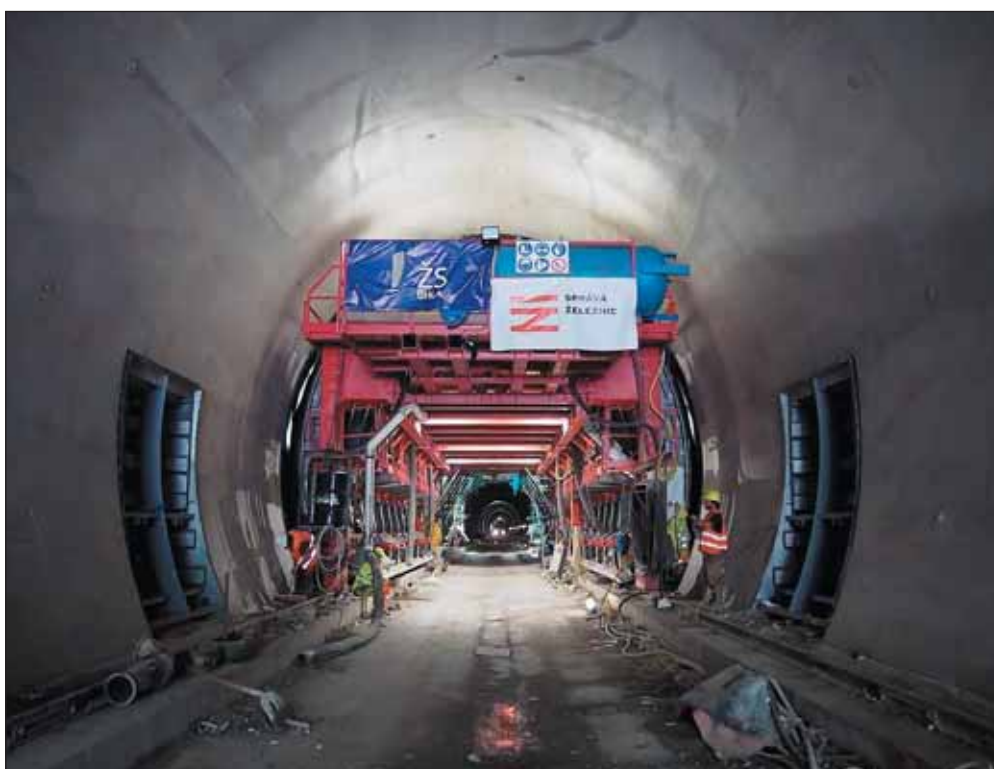
Obr. 11 Pojízdné ocelové bednění pro betonáž horní klenby
Fig. 11 Mobile steel traveller formwork for concreting the upper vault

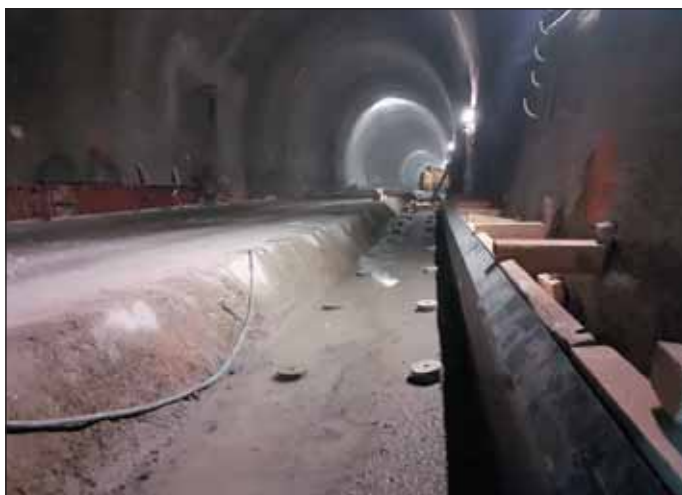
Obr. 12 Příprava pro armování a betonáž základového pásu
Fig. 12 Preparation for installation of reinforcement and concreting of a foundation strip

The excavation for the foundation strips and placement of the C 12/15 X0 grade blinding concrete was carried out ca 1.5 months in advance of the actual tying-up of the reinforcement and concreting of the foundation strips. The excavation for the foundation strips already started in mid-April 2022 from the Adamov portal. Precast SikaDrainage PVC parts, placed on the sloped blinding concrete, were used for the longitudinal drainage system. They were anchored in the correct position preventing displacement, and then perforated PVC drainage pipes Ø 200mm were installed in them. Then they were covered with 16/22mm-fraction pea gravel. The side formwork for the concreting of the foundation strips was created on one side by a skew surface of the cutting in the original tunnel lining segments in combination with vertical PERI formwork parts. On the other side, the formwork was created by a vertical wall of plastic prefabricated part. Reinforcement cages, cable protection pipes and concrete for the foundation strips were placed into the space prepared in this way (Fig. 12).

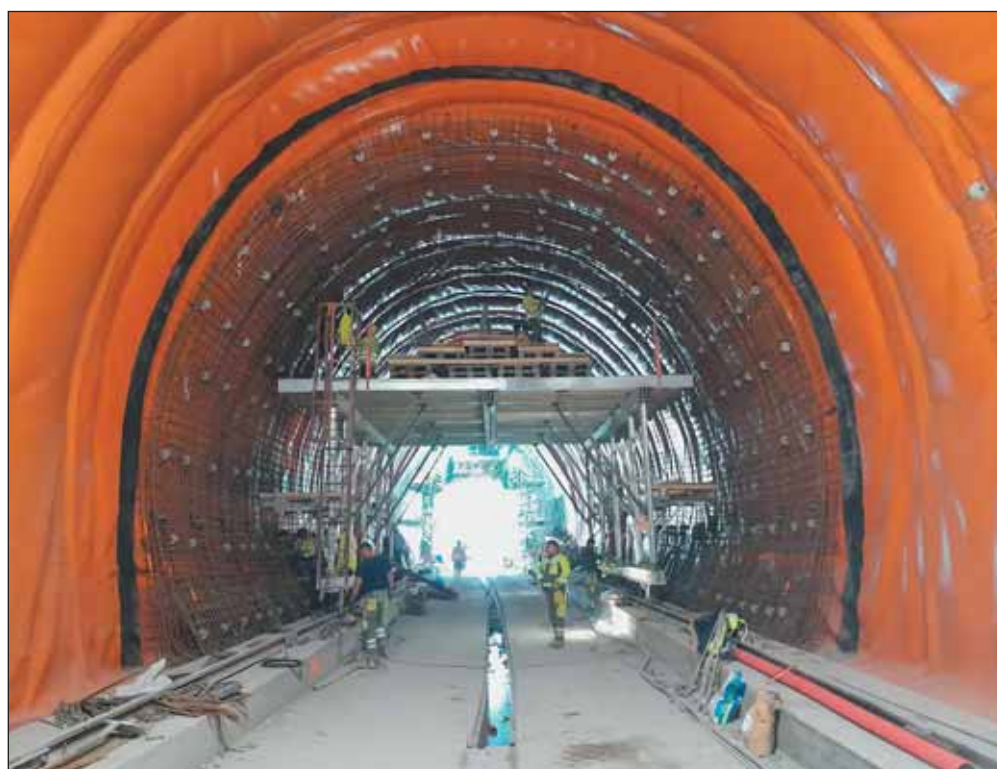
Obr. 13 Armovaný úsek horní klenby s hydroizolací
Fig. 13 Reinforced concrete section of the upper vault with waterproofing

The self-supporting reinforcement consisting of lattice girders, supplemented on the inner and outer faces with KARI mesh and loose additional reinforcement, was designed for the upper vaults of the portal and inner tunnel blocks. The weight of the reinforcement of the upper vault of the blocks P1 and 1 at the Adamov portal in the area of hard granodiorites was ca 5t, or 7t per 1 block. At the Blansko portal, the weight of the reinforcement of the upper vault for blocks 41 to 44 was about 12t per 1 block. At the time of concreting of the first block of the upper vault on June 21, 2022, the concreting of foundation strips was finished up to approximately half the tunnel length. The concreting of the other upper vault blocks continued almost regularly in a cycle of two days until the end of the operations. For the concreting of the upper vault, the completion concreting of the invert of the secondary lining on the last five tunnel blocks in time was the key operation so that the concrete could get cured and the formwork (weighing 110 tonnes) could enter the invert belts. There was an about 20-day time difference between concreting of the upper vaults and invert of the same block. The concreting of the last block at the Blansko portal was completed on October 10, 2022. The time of filling the formwork of one regular 12.5m long block was normally 8h with an average volume of concrete of 130m³. The designer proposed masonry facing of the portal parts of the tubes and giving them an original architectural appearance that is stylistically related to the neighbouring original brick-walled portal of tunnel No. 8/1 and the adjacent cladding walls (Fig. 14).

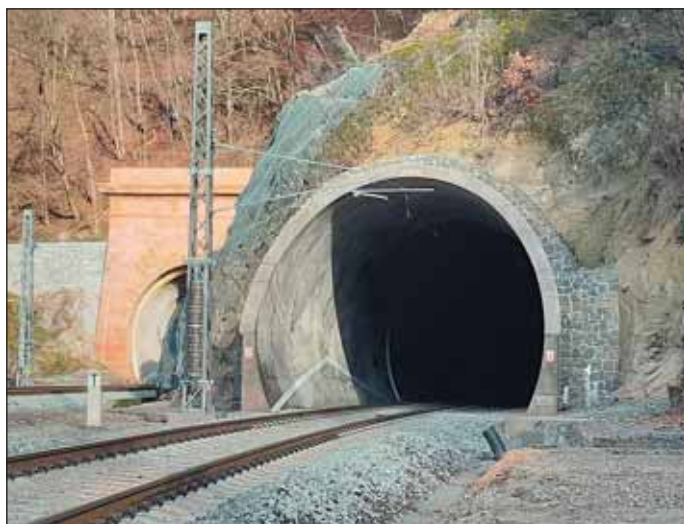
Obr. 14 Adamovský portál P1 po přestavbě, prosinec 2022
