STAVBA ČERVENKA, PROTLÁČENÝ PODJEZD POD ŽELEZNIČNÍM KORIDOREM ČESKÁ TŘEBOVÁ – OLOMOUC

ČERVENKA PROJECT, JACKED PASSAGE UNDER ČESKÁ TŘEBOVÁ – OLOMOUC RAIL CORRIDOR

MICHAL SODOMKA

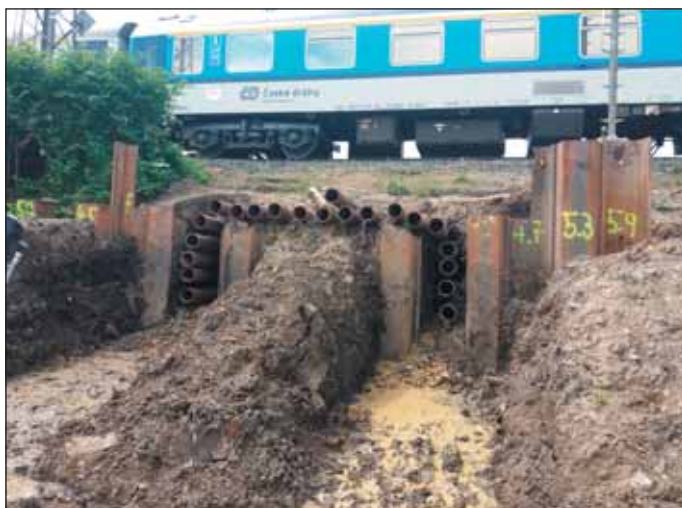
Obr. 1 Dokončený ochranný deštník
Fig. 1 Completed canopy tube pre-support

Na realizaci mikropilot byla použita vrtná souprava Grundodrill 25N, pomocí níž se podařilo dosáhnout směrové a výškové přesnosti horizontálních vrtů pro „ochranný deštník“ (až na jednu výjimku) v rozmezí ± 10 cm (obr. 1). Vzhledem k tomu, že část vrtů musela projít přes starou záporovou stěnu, o jejíž existenci nebylo v době provádění vrtných prací povědomí, lze tento výsledek pokládat za výborný.

the canopy tube pre-support (with one exception) within ± 10 cm (Fig. 1). With respect to the fact that part of the boreholes had to pass through an old soldier beam and lagging wall, the existence of which was not known at the time of drilling, this result can be considered excellent.

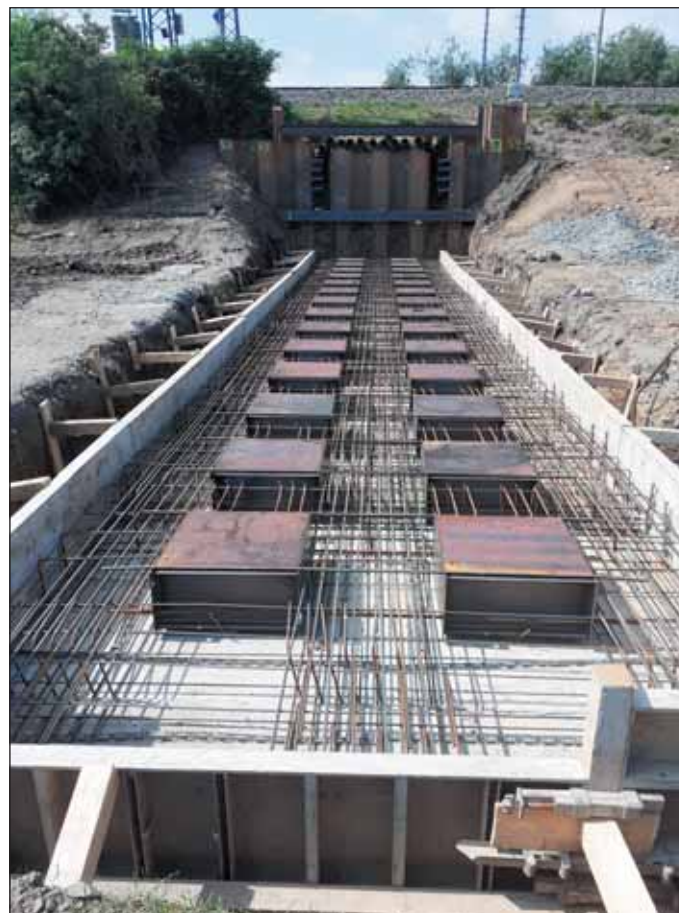
Obr. 2 Technologická rampa před betonáží
Fig. 2 Technology ramp before concreting

Po dokončení mikropilot bylo provedeno odtěžení zeminy v prostoru portálů. Následně se připravila samotná technologická rampa, jež měla za úkol navedení tubusu podchodu do správného směru a sklonu a zejména přenesení tlačných sil do podloží. Jednalo se o mohutnou železobetonovou desku (šířka 4 m, tloušťka 0,4 m a délka 24 m) z betonu C20/25-X0. Součástí této desky byly rovněž tři opěrné bloky provázané se základní deskou a zapuštěné 2 m pod úroveň rampy. Tyto bloky přenášely reakce tlačné síly do podloží. Součástí rampy byla soustava čtřnácti řad kapes, do kterých bylo postupně osazováno samotné protlačecí zařízení (obr. 2). Kapsy byly osazeny v „kroku“ 1,5 m ve dvou řadách. Opěrná plocha kapsy musela přenést tlak 4 000 kN.

After the completion of the canopy tubes, earth was excavated in the area of the portals. Subsequently, the technology ramp itself was prepared. Its task was to guide the underpass tube into the correct direction and gradient and, in particular, to transfer the thrust forces to the subgrade. It was a massive reinforced concrete slab (4m wide, 0.4m thick and 24m long) made of C20/25-X0 concrete. Three support blocks connected to the base plate and sunk 2m below the level of the ramp were also parts of the slab. These blocks transferred the thrust force reactions to the subgrade. A system of fourteen rows of pockets into which the jacking rig itself was gradually fixed (Fig. 2) was a part of the ramp. The pockets were carried out in two rows, at 1.5m spacing. The bearing surface of the pocket had to withstand a pressure of 4,000kN.

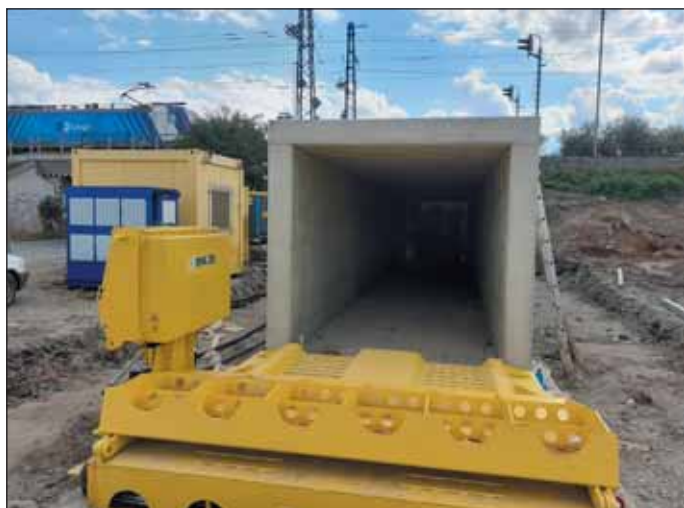
Obr. 3 Protlačecí souprava před zahájením ražby
Fig. 3 Jacking rig before the commencement of excavation

Samotná ražba podchodu byla zahájena 7. září 2020. Na přední čelo připraveného monobloku podchodu byl osazen „předšíték“, jehož základní funkcí bylo eliminovat případné komínování a vliv sypného úhlu zeminy na čelbě. Na opačném konci monobloku byla osazena tlačná stolice (obr. 3), která zajišťovala posun celé kolony.

Excavation of the tunnel itself began on September 7, 2020. An advance shield was mounted on the front face of the prepared block of the underpass structure. The basic function of the shield was to eliminate a possible overhead collapse and the influence of the angle of the earth repose at the excavation face. A jacking assembly (Fig. 3), which ensured the movement of the entire column was installed at the opposite end of the block.

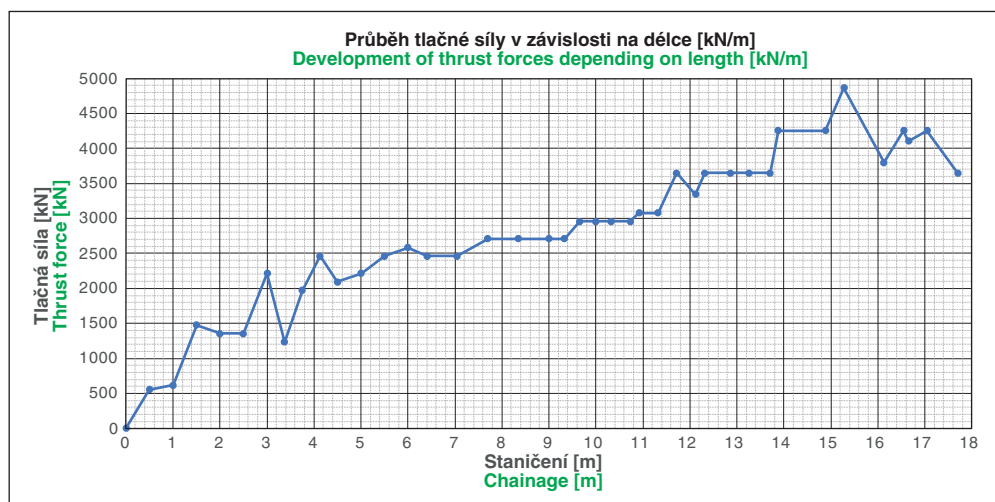
Obr. 4 Graf vývoje tlačných sil
Fig. 4 Graph of the development of thrust forces

Ražba podchodu byla prováděna strojně, kdy těžení probíhalo minibagrem a odvoz zeminy smykovým nakladačem. Původně zavedené odtěžování zeminy pomocí sacího bagru bylo v zastížené geologii (zvodnělé jílovité zeminy) vyhodnoceno jako málo efektivní. Velmi často totiž docházelo k ucpávání sacího potrubí, a proto bylo nutné přistoupit ke změně na smykový nakladač. Od tohoto okamžiku probíhala ražba plynule bez větších obtíží. Za jednu dvanáctihodinovou směnu se dařilo vyrazit až 3 m podchodu, jak byl tubus postupně zatlačěn do tělesa náspu, úměrně tomu narůstaly i tlačné síly. Zpočátku, když se předšíték nacházel pod svahem tělesa dráhy (ve staničení 3 m), se tlačná síla pohybovala do 2 000 kN (obr. 4).

I přes tuto komplikaci byl i po noční směně držen plánovaný harmonogram. Od této chvíle už práce nenarušovalo nic nepředvídaného a následující ranní směna vyrazila další 4 m. S tím začaly pomalu narůstat i tlačné síly s hodnotami kolem 4 250 kN. I přesto zůstávaly v předem stanoveném rozsahu pod 4 600 kN. Nejvyšší

The underpass excavation was carried out mechanically, using a mini-excavator for excavation and earth was removed with a skid-steer loader. The originally introduced earth removal using a suction excavator was evaluated as not very effective in the geology encountered (water bearing clayey earth). The suction pipe was very often clogged, and therefore it was necessary to replace it with a skid-steer loader. From that moment on, the excavation proceeded smoothly without major difficulties. In one twelve-hour shift, up to 3m of the underpass were excavated. As the tube was gradually jacked into the embankment, the thrust forces increased accordingly. Initially, when the advance shield was located under the slope of the track bed (chainage of 3m), the thrust force ranged up to 2,000kN (Fig. 4).

Despite this complication, the planned schedule was adhered to even after the night shift. From this moment on, the work was no longer interrupted by anything unforeseen, and the following morning shift excavated another 4m of the underpass. With this, the thrust forces began to slowly increase with the values of around 4,250kN. Even so, they remained within the predetermined range below 4,600kN. The highest value of the thrust force of 4,860kN was achieved at the chainage of 15.5m (without the use of sliding grouting). As the underpass breakthrough approached, the geology began to change. Sandy clays and cinder appeared at the excavation face, the advance shield reached the bracing of the exit portal and the tube was successfully thrust into the designed position (Fig. 6). Thus, a breakthrough

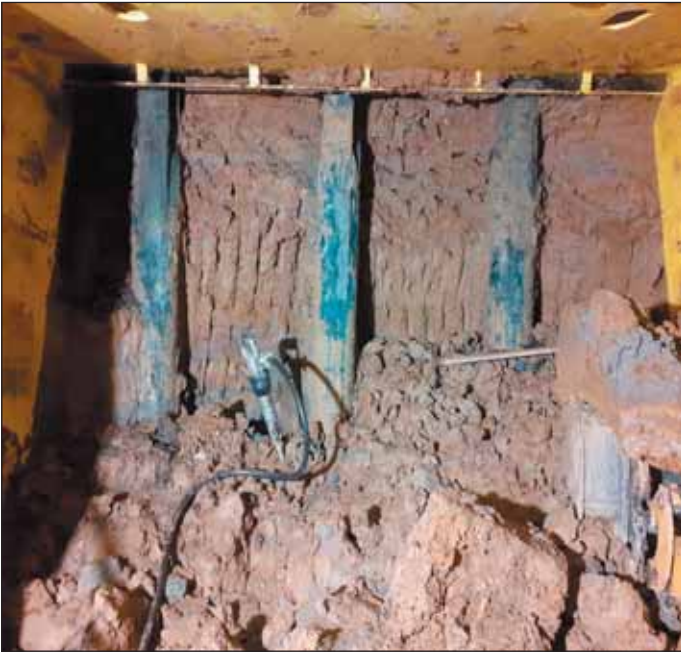
Obr. 5 Profily HEB původního záporového pažení zastižené na čelbě
Fig. 5 HEB sections of the original soldier beam and lagging bracing encountered at the excavation face

9,5 m. Při noční směně však došlo v tomto staničení k náhlému zvýšení odporu předstítku. Razičské práce byly ihned zastaveny, aby bylo možné ověřit, co je příčinou náhlého zvýšení tlačných sil. Na čelbě byla odtěžena zemina a příčina byla jasná – tři vrty z původního záporového pažení použitého při rozšiřování tratě, se zabetonovanými profily HEB 200 (obr. 5).

The excavation proceeded continuously in day and night shifts up to chainage of 9.5m. However, during the night shift, the resistance to the advance shield at this chainage suddenly grew. The excavation operations were immediately stopped to verify the cause of the sudden increase in thrust forces. The earth was excavated at the face and the cause was clear – three boreholes from the original soldier beam and lagging wall used during the enlargement of the track width, with HEB 200 profiles encased in concrete, were encountered (Fig. 5).

Fortunately, the soldier beams position was between the rails, which, after an agreement with the line administrator, allowed for their complete exposure and cutting. This also clarified the difficulties in drilling for the canopy tube pre-support, as described above.

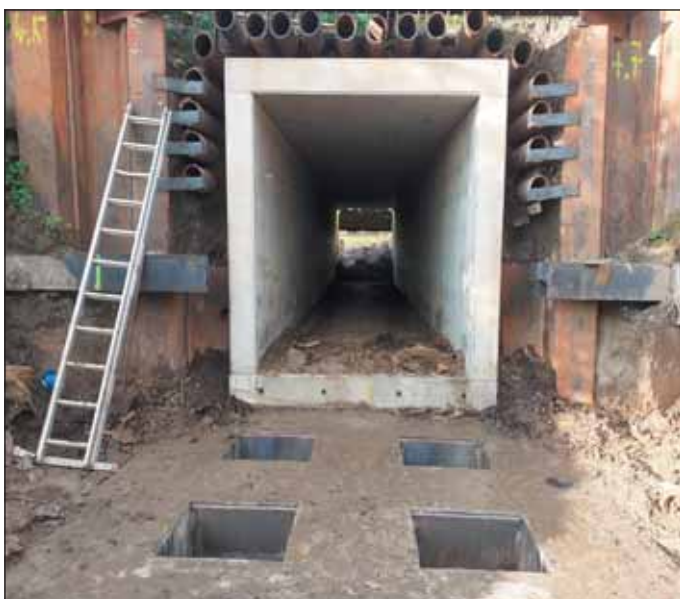
Obr. 6 Pohled do vyraženého díla
Fig. 6 A view down the excavated working

hodnota tlačné síly 4 860 kN byla dosažena ve staničení 15,5 m, a to bez použití kluzné injektáže. S blížícím se proražením podchodu se začala měnit geologie. Na čelbě se objevily písčité hlíny a škvára, předstítek dosáhl pažení výjezdového portálu a tubus byl úspěšně protlačen do projektované polohy (obr. 6). Tím tedy byla na následné třetí noční směně provedena slavnostní prorážka.

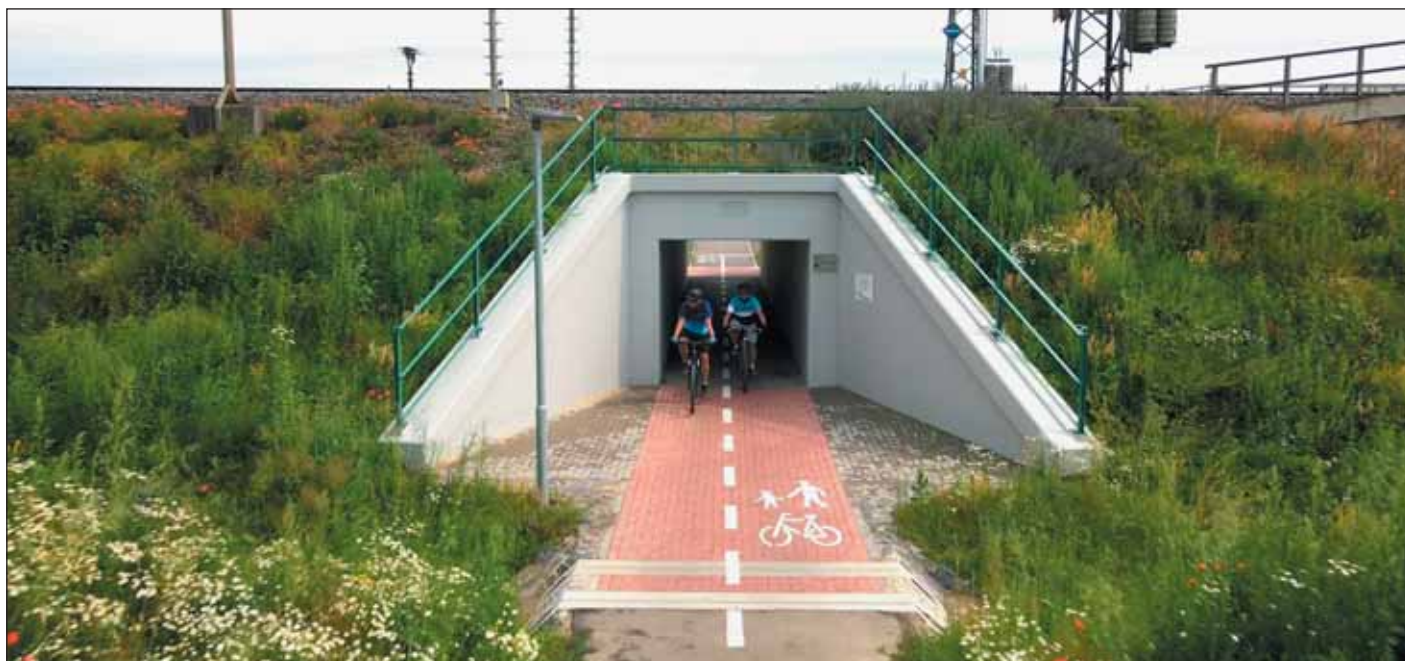
Obr. 7 Pohled na dokončený podchod
Fig. 7 A view of the completed underpass

Zdařilou realizaci nejlépe dokumentuje obr. 7. Z něj by i specialista těžko odhadl, že tento podjezd čtvercového průřezu byl realizován protlakem, s nízkým nadložím a pod provozovaným železničním koridorem. Nelze než přát, a to nejen cyklistům, ať tento pilotní projekt není zdaleka poslední!

The successful construction is best documented by Fig. 7. It would be hard even for a specialist to guess that this square cross-section underpass was constructed by jacking, under a low overburden and under an operating rail corridor. One can only wish, and not only to cyclists, that this pilot project is far from the last!
