REKONSTRUKCE DĚČÍNSKÉHO A LOUBSKÉHO TUNELU

RECONSTRUCTION OF THE DĚČÍNSKÝ AND LOUBSKÝ TUNNELS

JAROSLAV LACINA, LENKA KOČÍ, LUMÍR KLIŠ

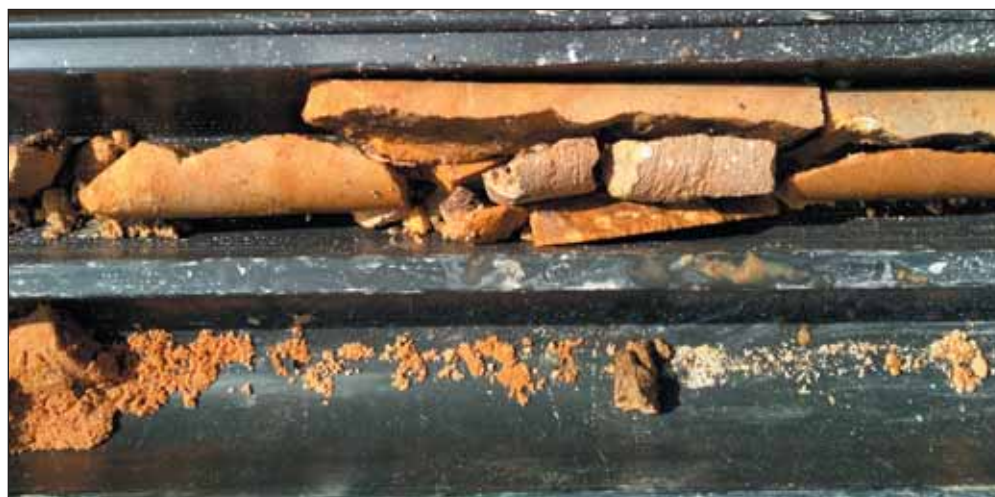
V rámci projektové přípravy rekonstrukce trati byl proveden i průzkum tunelu [3], [4] a [5]. Nejzávažnějším zjištěním byl fakt, že v hloubené části nebyla před zasypáním provedena hydroizolace tunelové klenby. Při rekonstrukci v letech 1968–1971 byl líc klenby uzavřen vrstvou stříkaného betonu a částečně bylo zdivo proinjektováno cementem. Tím bylo znemožněno prosychání zdiva zevnitř. Pískovcové zdivo klenby v hloubené části bylo vlivem prosakující vody degradované, mělo výrazně sníženou pevnost. V rámci realizovaného vrtného průzkumu [2] byly provedeny vrty do klenby ve všech tunelových pasech hloubené části tunelu. Ve vrtných jádrech byly zjištěny polohy rozpadlého pískovce; z odebraných vzorků měla velká část pevnost v tlaku menší než 10 MPa. V některých částech klenby chybělo pojivo mezi kameny (obr. 1).

Obr. 1 Rozpad kamenné obezdívky – detail části sondy v TP12

Fig. 1 Disintegration of the stone wall – detail of part of the probe in TP12

the cut and cover part of the tunnel. The positions of disintegrated sandstone were found in the drill cores; of the samples taken, a large part had a compressive strength of less than 10MPa. In some parts of the vault, the binder between the stones was missing (Fig. 1).

V pasech, ve kterých byla průzkumem zjištěna nízká pevnost kamenných kvádrů zdiva (většinou 4 až 15 MPa), byla provedena výměna klenby. Jedná se o pasy P1 až TP12. Původní kamenná klenba byla vybourána a nahrazena železobetonovou konstrukcí, výměna byla prováděna z otevřeného výkopu, kterému předcházely zajišťovací práce v tunelu a stabilizace prostředí okolo tunelové trouby tak, aby bylo možno zachovat původní opěry v úseku výměny.

In the sections where the investigation revealed low strength of the masonry stone blocks (mostly 4 to 15MPa), the vault was replaced. These are sections P1 to TP12. The original stone vault was demolished and replaced by a reinforced concrete structure, the replacement was carried out from an open cut, which was preceded by support of the tunnel and stabilization of the area around the tunnel tube so that it was possible to preserve the original supports in the reconstructed section.

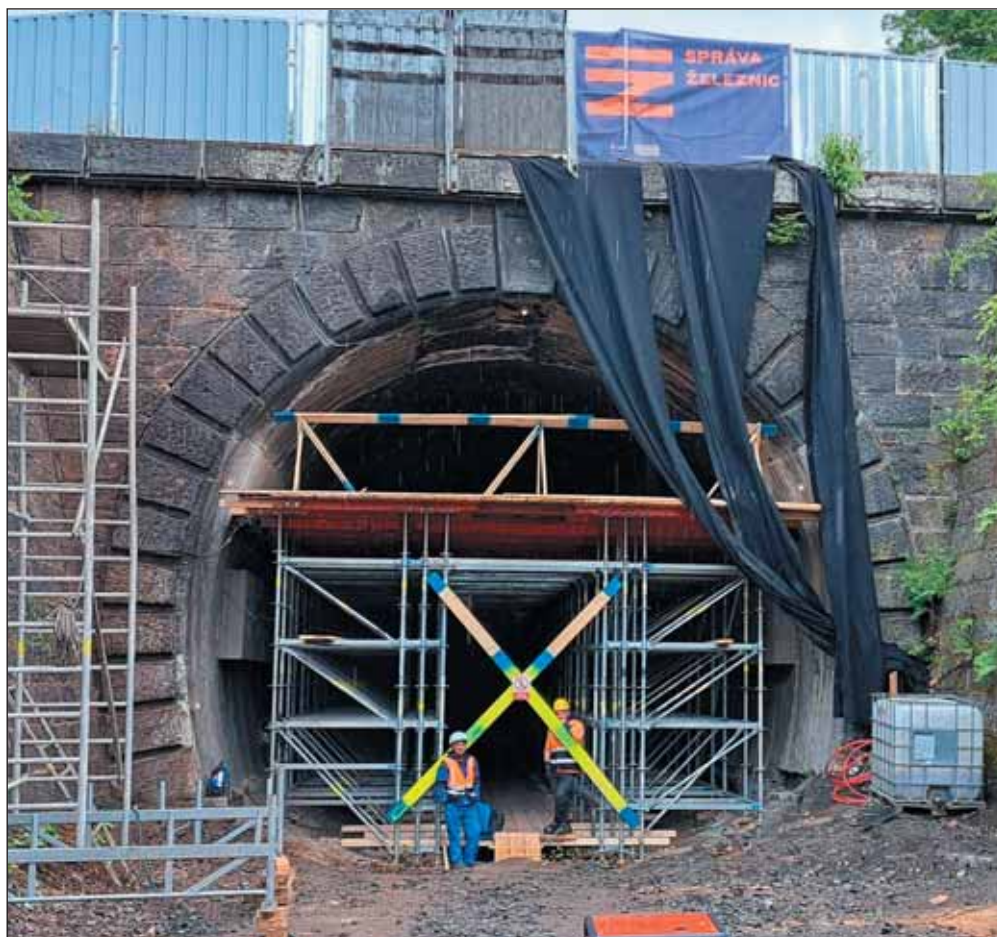
Před zahájením zemních prací nad tunelem bylo kromě přikotvení opěr provedeno rozepržení tunelu ve výšce cca 0,6 m pod bouranou částí klenby pro zajištění stability konzoly tunelové obehdivky (která po vybourání klenby zůstala stát). Rozepržení bylo

Obr. 2 Rozepržení tunelu před bouráním klenby
Fig. 2 Bracing the tunnel before demolishing the vault

Before starting earthworks above the tunnel, in addition to anchoring the abutments, the tunnel was braced at a height of approx. 0.6m below the demolished part of the vault to ensure the stability of the tunnel lining (which remained standing after the vault was demolished). The bracing was carried out together with the formwork of the new vault. This served during the construction period as protection of the formwork system against damage by the demolished material and in the deep part of the construction pit in the section TP8 to TP12 also as support for the existing vault for the time of retaining the construction pit (Fig. 2). Bracing and formwork was carried out by PERI formwork

realizováno společně s bedněním nové klenby. To sloužilo po dobu výstavby jako ochrana bednicího systému před poškozením bouřným materiálem a v hluboké části stavební jámy v úseku TP8 až TP12 i jako podpora stávající klenby po dobu zajištění stavební jámy (obr. 2). Rozepření a bednění bylo provedeno systémovými prvky bednění PERI. Jednalo se o vodorovné prvky VARIOKIT v rozteči 1,25 m, podepřené dvěma věžemi stejného systému. Vzpěra byla podpůrnými věžemi zajištěna proti vybočení ve všech směrech. Vzpěrné elementy byly opřeny do ostění přes roznášecí ocelové prahy z válcovaných profilů. Přípustné síly v rozpěrách byly stanoveny hodnotou 170 kN. Tímto způsobem byla nahrazena původně navrhovaná klasická výdřeva tunelu ze statického posudku zadávací dokumentace.

system elements. These were horizontal VARIOKIT elements at a spacing of 1.25m, supported by two shoring towers of the same system. The bracing was secured against buckling in all directions by shoring towers. The bracing elements were leaned against in the lining through rolled steel beams. The permissible forces in the bracing were set at 170kN. In this way, the originally proposed classic timber support tunnel construction of the tender static calculation documentation was replaced.

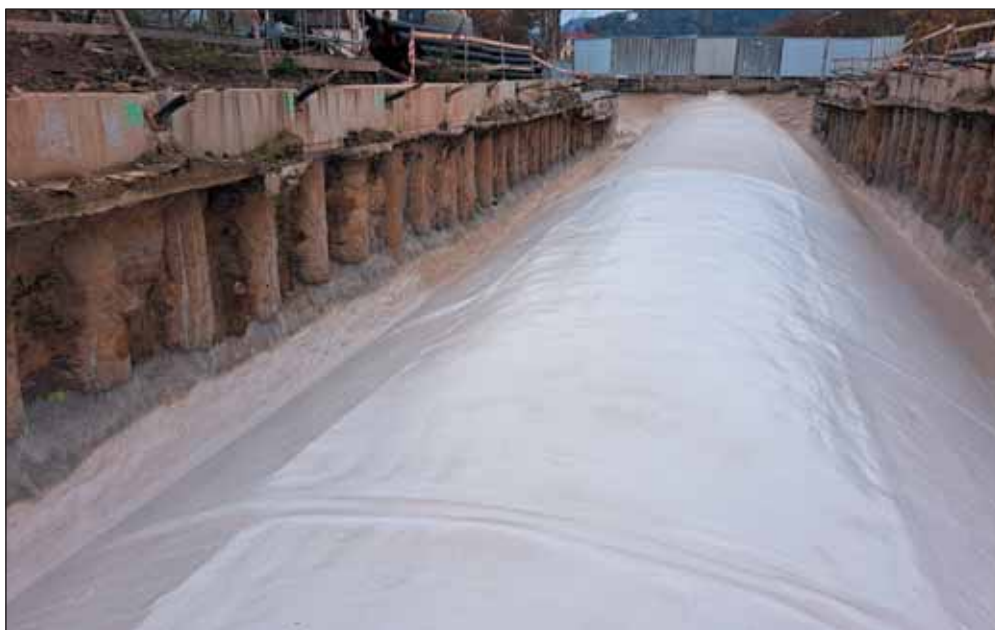
Obr. 4 Rubová stříkaná hydroizolační membrána nové klenby tunelu
Fig. 4 Back side sprayed waterproofing membrane of the new tunnel vault

The new reinforced concrete vault was designed in transverse section defined by an angle of 120°. Its thickness was the same as the average thickness of the original stone vault of 800mm, Fig. 3. The vault was connected to the original abutments by means of a pair of Ø R20 chemically anchored steel bolts of length 500mm at a spacing of 330mm to a in a waterproofed construction joint. The waterproofing system was designed to a reasonable extent in accordance with TNŽ 73 6280 (Technical Standard for Railways). As protection against running water, a flexible waterproofing sprayed membrane MasterSeal (manufactured by SIKA) with a thickness of 2 to 5mm. It was applied directly to the back of the new vault. The termination of the waterproof layer in the transverse direction was carried out up to the retaining wall of the construction pit approx. 800mm above the level of the excavation behind the back of the vault (Fig. 4). In the longitudinal

direction, the waterproofing was finished at the beginning of the section on the back side of the portal wall on a leveling layer of sprayed concrete. In the sense of TNŽ 73 6280, the membrane was protected as “stiff” with a sprayed concrete layer of 50mm minimum thickness with one layer of reinforcing steel mesh.

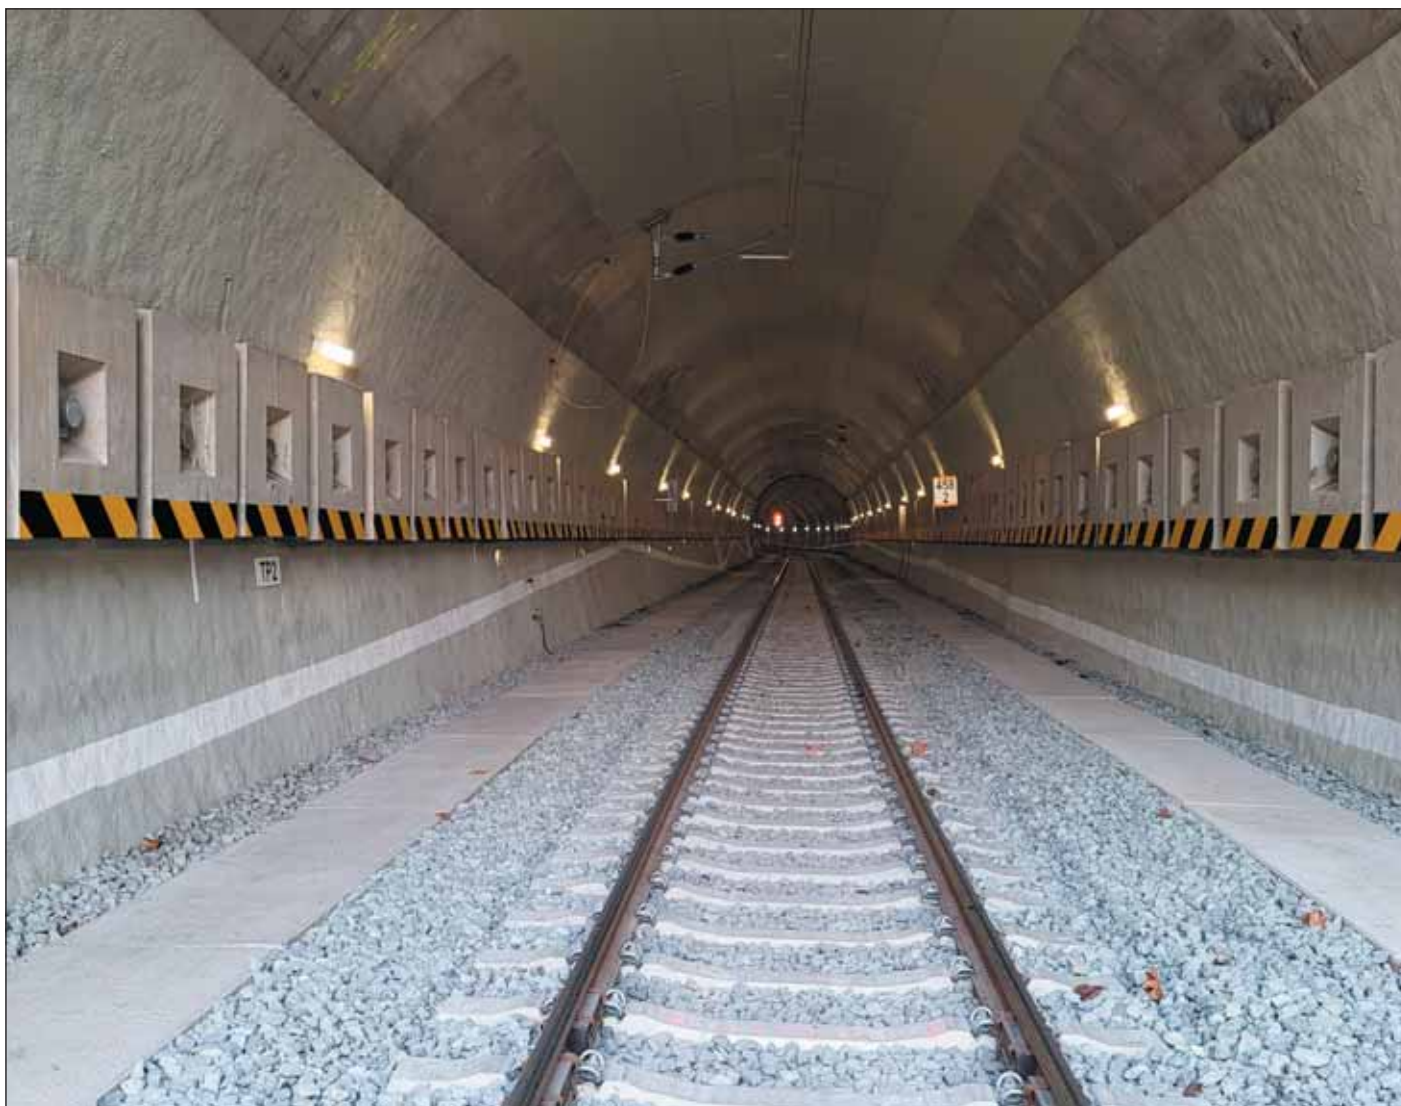
*Obr. 7 Pohled do hloubené části Děčínského tunelu po rekonstrukci
Fig. 7 View of the cut and cover part of the Děčínský Tunnel after reconstruction*

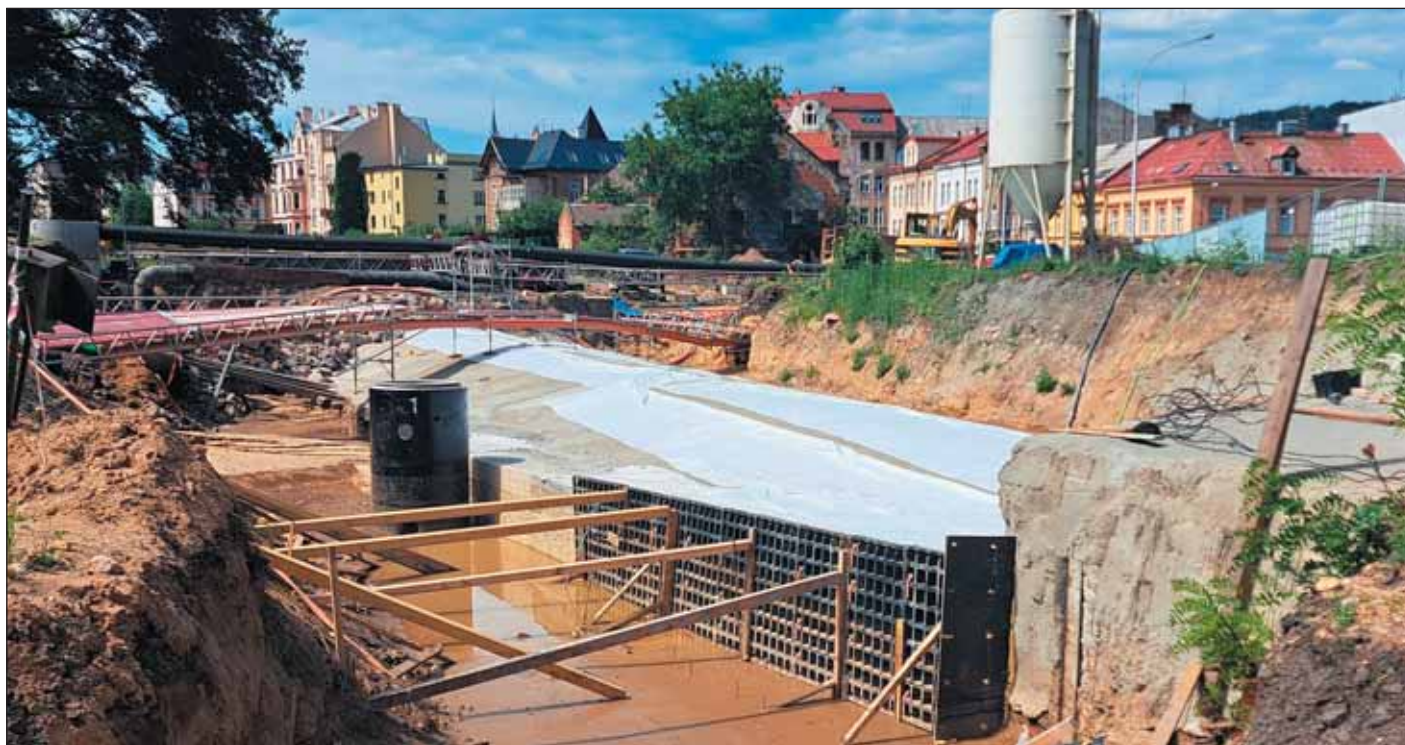
Obr. 8 Pohled na izolovaný rub klenby Loubského tunelu

Fig. 8 View of the waterproofed back side of the Loubský tunnel vault

Hydroizolace klenby byla provedena z rubu pružnou hydroizolační stříkanou membránou MasterSeal 345 (výrobce SIKA) tl. 3 až 6 mm (obr. 8). Ochrana vodotěsné vrstvy byla provedena jako tvrdá ve smyslu TNŽ 73 6280 vrstvou stříkaného betonu tl. min. 50 mm s jednou vrstvou kompozitní výztužné sítě z čedičových prutů 3 × 100/3 × 100 mm. Součástí ochrany proti pronikající vodě bylo také odvedení podzemních vod z prostoru nad sanovaným stropem tunelu. Byly provedeny dvě postranní drenážní stoky DN 150, které byly zaústěny do projektovaných šachet svodného potrubí železničního svršku.
