RAŽENÉ TUNELY JAKO SOUČÁST TUNELOVÉHO KOMPLEXU BLANKA

MINED TUNNELS ON THE BLANKA COMPLEX OF TUNNELS

JAN KVAŠ, MILOSLAV ZELENKA, MILOSLAV SALAČ

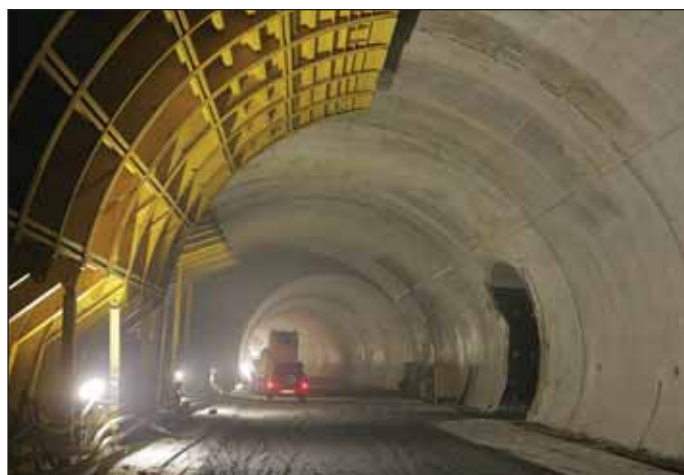
Obr. 1 Bednění sekundárního ostění zálivu
Fig. 1 Formwork for secondary lining of the emergency parking bay

- The safety concept of the construction defining the number and locations of emergency parking bays was updated so that conditions of the reviewed standard ČSN 73 7507/2006 were met. As the result of this reconsideration, the emergency parking bays in the NTT and STT which had originally been designed to be built in the extreme geological conditions under the Stromovka Park, were moved to a location beyond the Šlechta's Restaurant, which location was less convenient in terms of the final operation of the tunnel, where the rock cover thickness rose to 11 – 24m, where a rock environment categorised as excavation class 4 was specified.

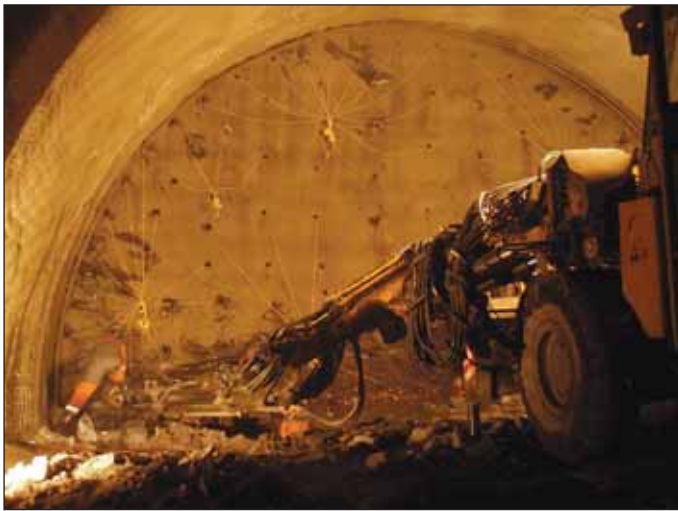
Obr. 2 Příprava k odstřelu
Fig. 2 Preparation for blasting

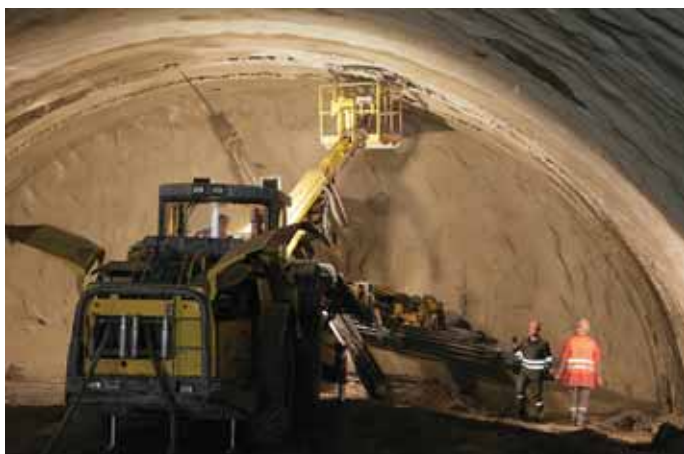
Obr. 3 Ražba kaloty STT tunelu Brusnice
Fig. 3 Brusnice NTT top heading excavation

The NTT and STT excavation commenced on 09/10/2009 and 09/01/2010 respectively. The NTT is being driven using a horizontal excavation sequence for the planned length of 366m. The excavation at the beginning of the NTT were planned with the aim of closing the whole tunnel profile within an about 30m long tunnel section. Then the excavation proceeds with the top heading at the distance of about 60–80m ahead of the bench. The drill-and-blast is used during the excavation; rock is broken only mechanically in deteriorated conditions. Several stranded anchors supporting the portal were encountered when the NTT top heading and later the bench excavation started. They were put out of action by the excavation. A trigonometric survey on survey points installed on the portal wall proved displacements and tension dynamometer measurements showed a significant increase in tensile forces. These manifestation stabilised when the NTT profile had been closed and some measures had been implemented directly at the portal. The STT excavation started using a vertical excavation sequence. This vertical sequence was prescribed for a
