PRŮZKUMNÉ ŠTOLY VYUŽITÉ PRO VÝSTAVBU DOPRAVNÍCH TUNELŮ V ČR

EXPLORATORY GALLERIES USED FOR CONSTRUCTION OF TRANSPORT TUNNELS IN THE CR

MARTIN SRB, MATOUŠ HILAR

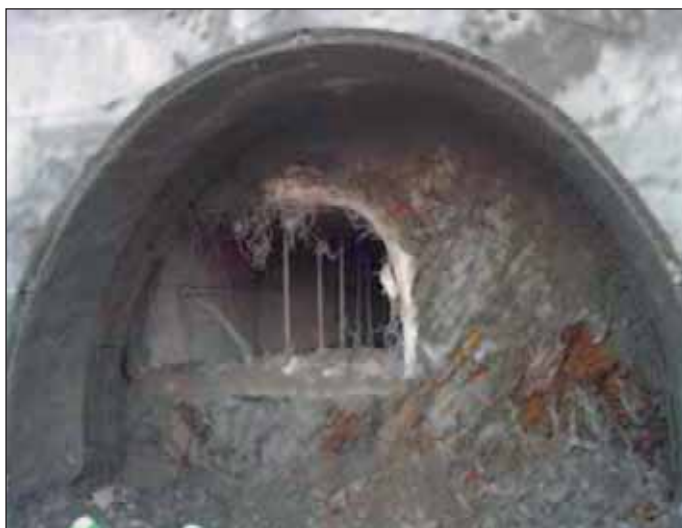
Obr. 2 Průzkumná štola tunelu Valík
Fig. 2 Exploratory gallery for the Valík tunnel

Průzkumná štola s profilem 15 m² byla budována v profilu budoucího středního tunelu s profilem cca 71 m² (kalota 50 m² a spodní klenba cca 21 m²) v celé délce tunelu (obr. 2). Ve středním tunelu byl vybudován monolitický betonový pilíř sloužící jako opěra pro primární ostění při ražbě vlastních tunelových trub.

The exploratory gallery with the cross-sectional area of 15 m² was driven within the profile of the future central tunnel with the cross-sectional area of 71 m² (top heading 50 m² and invert about 21 m²), throughout the tunnel length (see Fig. 2). A concrete pillar fulfilling the role of a support for the primary lining during the excavation of the tunnel tubes themselves, was cast in the central tunnel.

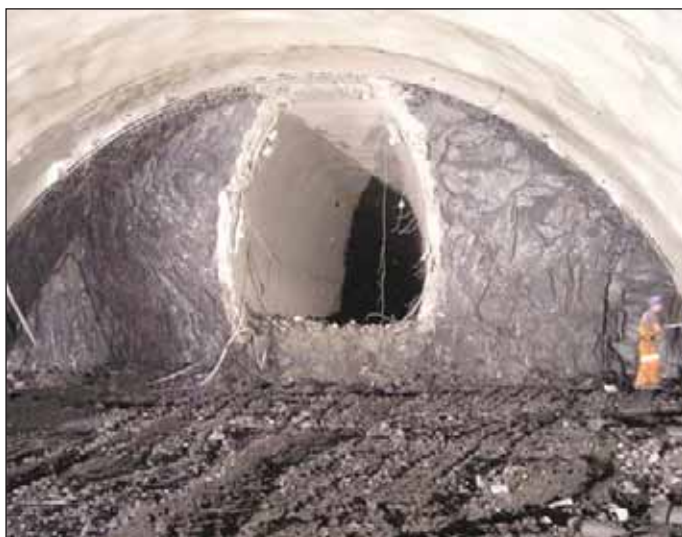
Obr. 3 Průzkumná štola tunelu Komořany
Fig. 3 Exploratory gallery for the Komořany tunnel

U dané stavby bylo rozhodnuto provést průzkumnou štolu v celé délce, protože nejobtížnější geotechnické poměry byly očekávány ve střední části, kde měla být také umístěna větrací šachta. Tvar štoly a její umístění v profilu tunelu se v průběhu přípravy upravovaly. Realizovala se štola o velikosti cca 25 m² soudkového tvaru, umístěná do osy kaloty třípruhového tunelu s nadvýšeným stropem, který zůstal jako „ztracený“ při ražbě plného profilu (obr. 3). Portály štoly byly posunuty až do míst hloubených portálů tunelu z důvodu plochy zařízení staveniště limitované výkupem pozemků, přístupem na ně a zpožděním přeložky frekventované komunikace Komořanská. Štola byla delší než ražený tunel v Cholupicích o 56 m a v Komořanech o 175 m. Součástí štoly byly také rozšířené úseky tvaru plného profilu kaloty o délkách přibližně 30 m.

A decision regarding the particular construction was made that an exploratory gallery would be driven throughout the tunnel length because the most difficult geotechnical conditions were expected to be encountered in the central section, where a ventilation shaft was to be sunk. The geometry of the gallery cross-section and its position within the tunnel cross-section were adjusted during the planning phase. The gallery which was constructed was 25 m² in the barrel-shaped cross-section; it was driven along the top heading centre line of the future triple-lane tunnel top heading. The top of the gallery was higher than the top of the tunnel. The lining of the crown remained as a sacrificial structure when the full tunnel profile was being excavated (see Fig. 3). The gallery portals were shifted to the positions of portals of cut-and-cover tunnels because of the area required for the site facility, which was limited by the acquisition of land plots, access to them and a delay in the construction of a diversion of the busy Komořanská road. The gallery was longer than the mined tunnel by 56 m and 175 m in Cholupice and Komořany, respectively. Part of the gallery were approximately 30 m long sections where the profile was expanded to copy contour of the full tunnel top heading.

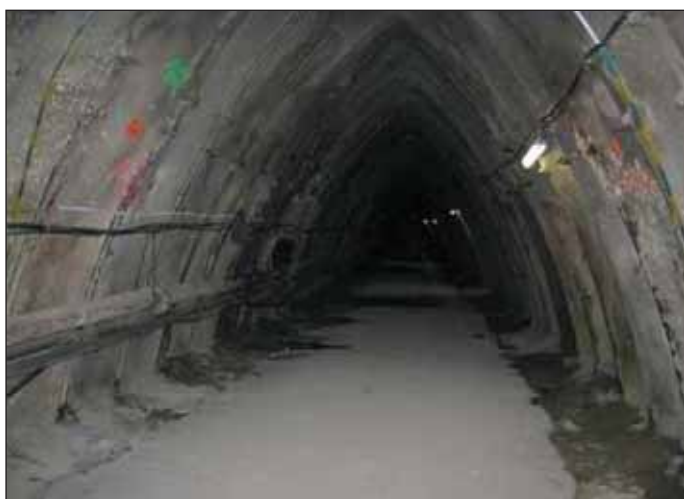
Obr. 5 Průzkumná štola Královopolského tunelu
Fig. 5 Exploration gallery for the Královo Pole tunnel

Součástí průzkumu bylo vyražení tří průzkumných štol přibližně trojúhelníkového příčného profilu v prostoru tunelových trub na bocích kaloty (obr. 5), které byly využity při následné výstavbě tunelového díla. Ražba štol probíhala z východního portálu a celková délka průzkumných štol činila přes 2 km (IIA 831 m, IIB 831 m a IB 365 m). Skutečné deformační chování (dlouhodobé, větší než očekávané deformace) průzkumných štol během realizace a především po ní bylo zohledněno v návrhu ražeb plných profilů.

were driven on the sides of the future tunnel top heading (see Fig. 5). They were used during the subsequent construction of the tunnels. The galleries were driven from the eastern portal. The total length of the exploratory galleries exceeded 2 km (IIA 831 m, IIB 831 m and IB 365 m). The actual deformational behaviour (long term deformations larger than expected deformations) of the exploratory galleries during the construction and, first of all, after the construction, was allowed for in the design for the excavation of full profiles.

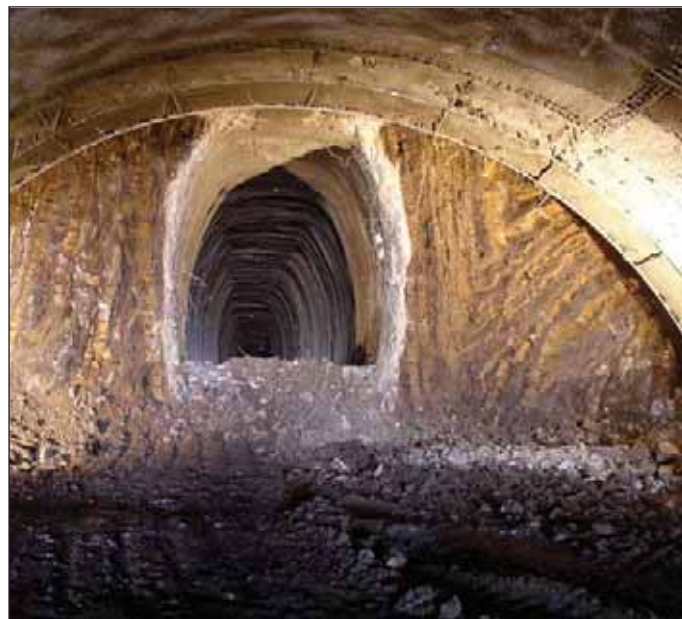
Obr. 4 Průzkumná štola tunelu Slivenec
Fig. 4 Exploratory gallery for the Slivenec tunnel

Štola o profilu 25 m² soudkového tvaru byla navržena jako stropní v pravém stoupajícím třípruhovém tunelu na celou délku tunelu (obr. 4). Výška štoly odpovídala výšce budoucí kaloty a byla nadvýšena podobně jako u štoly SOKP 513. Ve štole bylo realizováno sedm zvětšených geotechnických profilů na celou šířku kaloty v délkách 12 až 42 m s plochou výrubu cca 66 m², které byly využívány po dobu ražby i jako výhybny. Ražba štoly byla realizována v roce 2004.

The gallery with the barrel-shaped cross-section of 25 m² was designed as a crown drift following the future right-hand ascending triple-lane tunnel throughout its length (see Fig. 4). The gallery height corresponded to the height of the future tunnel top heading, exceeding the top heading roof level similarly to the gallery for the PCRR 513. Seven 12 to 42 m long geotechnical sections with cross-sections expanded to the full width of the tunnel top heading (excavated cross-sectional areas of about 66 m²) were carried out in the gallery. Among other purposes they were used during the course of the excavation as passing bays. The gallery was driven in 2004.

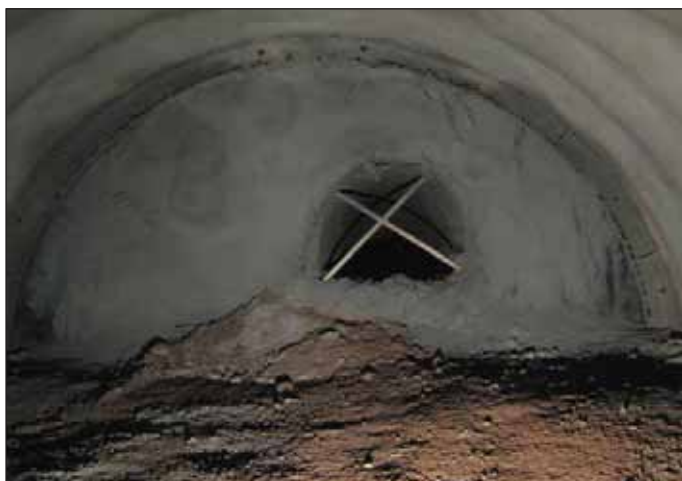
Obr. 6 Průzkumná štola tunelu Prackovice
Fig. 6 Exploration gallery for the Prackovice tunnel

Vlastní výstavbě tunelu Prackovice předcházela podrobný geologický průzkum včetně ražby průzkumné štoly ze šachty provedené v blízkosti severního (pražského) portálu. Ražba průzkumné štoly byla zahájena v prosinci 2004 a dokončena v červnu 2005. Plocha výrubu štoly byla 23,5 m², umístění v profilu budoucí kaloty levé (západní) tunelové trouby (obr. 6) a celková délka štoly byla 170 m. Ražba štoly a tunelu proběhla bez problémů, vyšší deformace jižního (pražského) portálu byly řešeny dodatečnými stabilizačními opatřeními.

The Prackovice construction itself was preceded by a detailed geological survey, including the excavation of an exploratory gallery from a shaft sunk in the vicinity of the northern (Prague) portal. The excavation of the exploratory gallery commenced in December 2004 and was finished in June 2005. The cross-sectional area of the gallery was 23.5 m². The gallery alignment followed the future top heading of the left-hand (western) tunnel tube (see Fig. 6). The total length of the gallery was 170 m. Both the gallery and the tunnel were driven without problems; larger deformations of the southern (Prague) portal were solved by additional stabilisation measures.

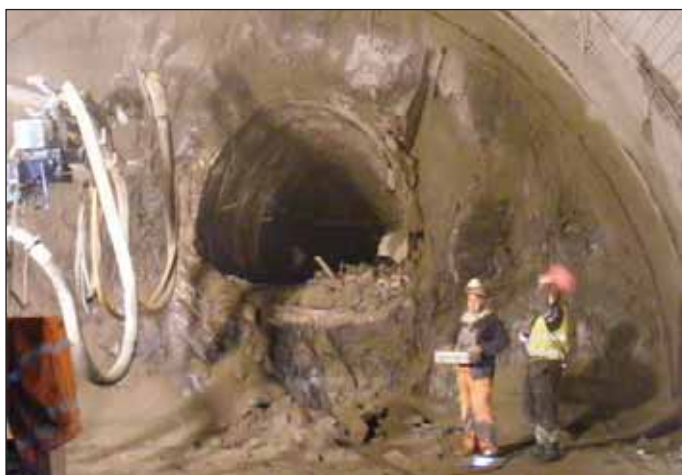
Obr. 7 Průzkumná štola tunelu Královská obora
Fig. 7 Exploratory gallery for the Královská Obora tunnel

Průzkumná štola o celkové délce 1950 m je ve své převážné délce vedena v profilu budoucí jižní tunelové trouby (JTT) a umístěna excentricky do vrcholu kaloty budoucího tunelu (obr. 7). Štola s profilem 10,5 m² byla realizována s kolejovou dopravou s výhybnami po 150 m. V úseku s nejnižším nadloží na úpatí svahu z Letné (oblast bývalé Šlechtovy restaurace) a také pod Vltavou byla průzkumná štola ražena i v profilu

The exploratory gallery with the total length of 1,950 m runs along the prevailing proportion of its length within the profile of the future southern tunnel tube (STT); it is positioned eccentrically at the crown of the top heading of the future tunnel (see Fig. 7). The gallery with the cross-sectional area of 10.5 m² was constructed using rail-bound transport and passing bays provided at intervals of 150 m. In the section with the shallowest cover at the bottom of the slope from Letná, the exploratory gallery was even driven within the profile of the future northern tunnel tube (NTT). In the section with the shallow cover under Stromovka Park, extensive stabilisation measures designed to improve conditions for the future tunnelling were implemented from the exploratory gallery.

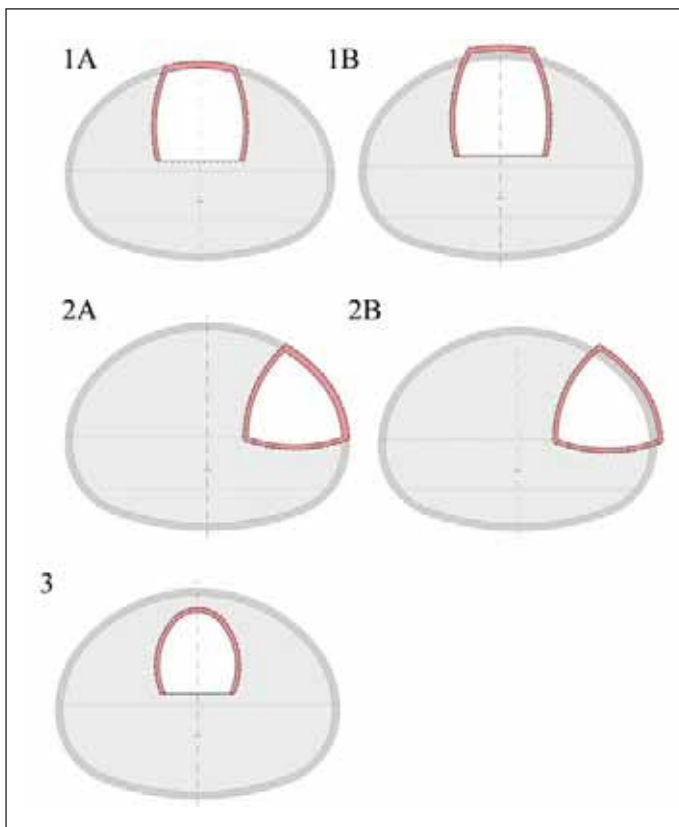
Obr. 8 Umístění a tvary průzkumných štol a jejich příklady (1 – SOKP 513, SOKP 514, 2 – Královopolský Brno, 3 – Mrázovka, Královská obora, Prackovice)

Fig. 8 Positions and geometries of exploratory galleries and their examples (1 – PCRR 513, PCRR 514; 2 – Královo Pole tunnel, Brno; 3 – Mrázovka, Královská Obora, Prackovice tunnels)

Z hlediska umístění byly v uváděných případech průzkumné štoly nejčastěji realizovány v následujících polohách a tvarech (obr. 8):

- 1 – Štola soudkovitého tvaru v ose kaloty – s nenadvýšeným (1A) či nadvýšeným (1B) stropem.
- 2 – Štola trojúhelníkového tvaru v oblasti opěrového (bočního) tunelu – s nenadvýšeným (2A) či nadvýšeným (2B) stropem.
- 3 – Štola podkovovitého tvaru v oblasti kaloty (s nadvýšeným či nenadvýšeným stropem).
- 4 – Štola umístěná mimo profil tunelu (paralelní s tunelem) využitelná při provozu tunelu pro účely úniku osob, větrání či odvodnění.
- 5 – Štola umístěná mimo profil tunelu (neparalelní s tunelem) sloužící během ražeb jako přístupová štola.

From the aspect of their position, the exploratory galleries mentioned in this paper were most frequently driven in the following positions within the future tunnel cross-section, with the following geometries (see Fig. 8):

- 1 – A barrel-shape gallery following the top heading centre line – with its roof at the same level as the tunnel roof (1A) or higher than the tunnel roof (1B).
- 2 – A triangular cross-section gallery driven in the area of the sidewall drift – with its roof at the same level as the tunnel roof (2A) or higher than the tunnel roof (2B).
- 3 – A horseshoe shaped cross-section gallery driven within the area of the top heading – with its roof at the same level as the tunnel roof or higher than the tunnel roof.
- 4 – A gallery driven outside the tunnel profile (in parallel with the tunnel), which can be used during the tunnel operation for escape, ventilation or drainage purposes.
- 5 – A gallery running outside the tunnel cross-section (non-parallel with the tunnel), which is used during the tunnel excavation as an access gallery.
