STAVBA DÁLNIČE D8 – 0805 LOVOSICE – ŘEHLOVICE, VÝSTAVBA TUNELŮ PRACKOVICE A RADEJČÍN

MOTORWAY D8 – 0805 LOVOSICE – ŘEHLOVICE PROJECT, CONSTRUCTION OF PRACKOVICE AND RADEJČÍN TUNNELS

JIŘÍ TROCHTA, PAVEL KUDĚJ, JIŘÍ SVOBODA, MICHAL HNILIČKA

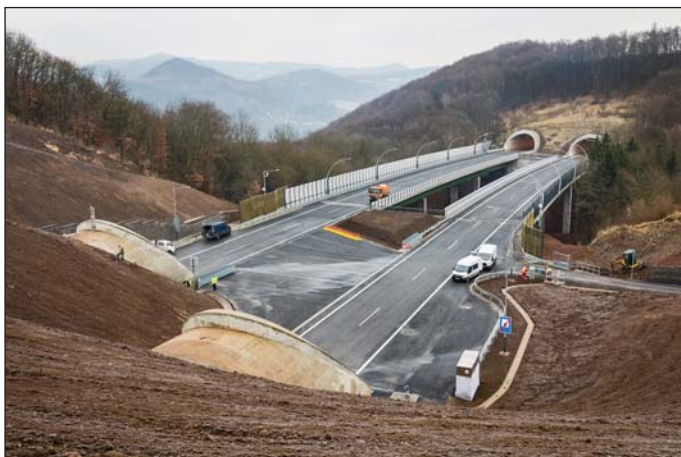
Obr. 3 Dálniční most mezi tunely – pohled z tunelu Radejčín ku Praze před uvedením do provozu

Fig. 3 The motorway bridge between the tunnels – a view from the Radejčín tunnel toward Prague – before opening to traffic

Composite steel-concrete slab of a girder type, a continuous beam with 3 spans. Substructure is formed by a pair of reinforced concrete side abutments and a pair of high and slender reinforced concrete piers. Combined shallow and deep foundation on large-diameter piles is designed for the substructure (see Fig. 3).

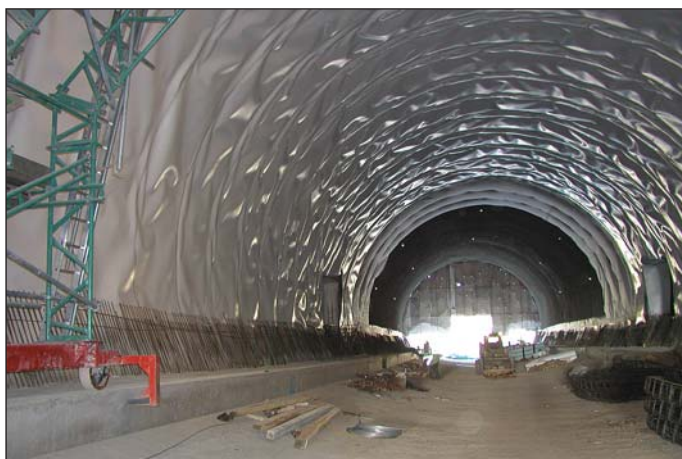
Obr. 4 Montáž izolační fólie
Fig. 4 Installation of waterproofing membrane

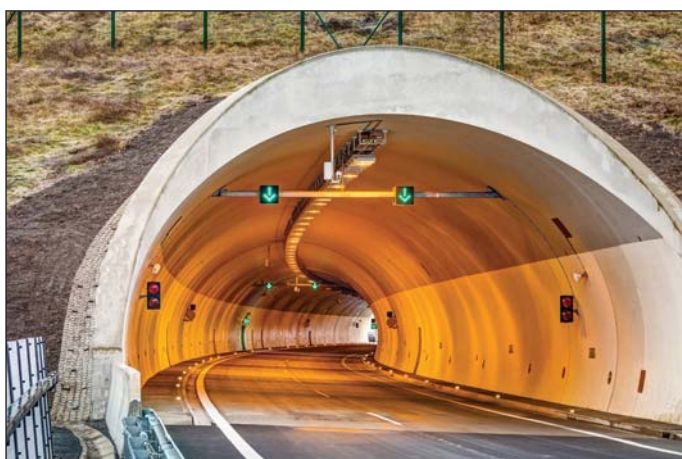
Obr. 5 Tunel Prackovice před uvedením do provozu
Fig. 5 The Prackovice tunnel before opening to traffic

Podkladní vrstva vozovky v obou tunelech byla vytvořena ze štěrkodrti frakce 0/63. Pokládka probíhala ve dvou etapách. Nejprve byla rozprostřena a zhutněna vrstva tloušťky 200–300 mm a potom následovala pokládka druhé vrstvy v tloušťce 200–260 mm. Vlastní vozovka je vyrobena z cementobetonového krytu, který je proveden jako dvouvrstvý o celkové tloušťce 240 mm (spodní beton 190 mm a horní beton 50 mm). Beton CB krytu je z třídy C 30/37 XF4 D max 8 (horní beton) a C 30/37 XF4 D max 22 (spodní beton). Na základě zkušeností z provozovaných tunelů byla změněna povrchová úprava CB krytu z příčné striáže na obnažené kamenivo, což umožnila i aktualizace ČSN 73 6123-1 z 06/2014. Jedná se o první použití této povrchové úpravy CB krytu v tunelu v ČR (obr. 5).

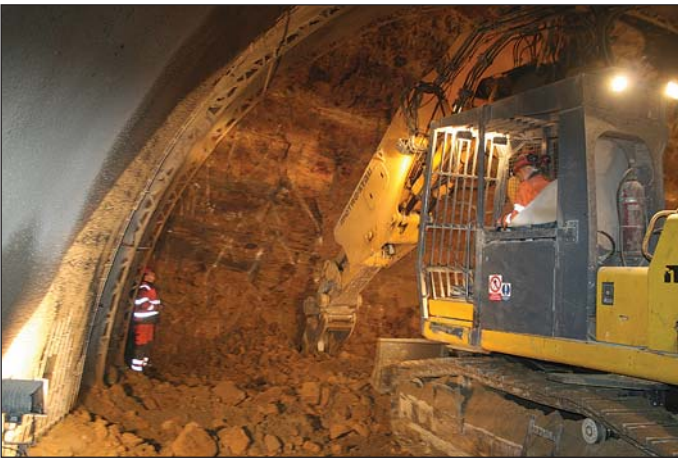
Obr. 6 Rozpojování horniny na čelbě**Fig. 6 Disintegration of rock at the excavation face**

The above-mentioned measures contributed to the stabilisation of deformations. They manifested themselves even further, only to a substantially lesser extent. After the completion of the tunnel excavation and casting of the final lining concrete in both tunnel tubes and, first of all, after the completion of final backfills, the deformations became completely stable. The excavation of the tunnels proceeded using the NATM. The following four excavation support classes were encountered: 3, 4, 5a and 5b. The primary lining sections in classes 5a and 5b had a reinforced concrete invert throughout their length. The drill-and-blast method prevailed when the tunnel profiles were being disintegrated, but when the tunnel excavation commenced at the tunnel portal, rock was disintegrated mechanically, using a tunnel excavator (see Fig. 6).

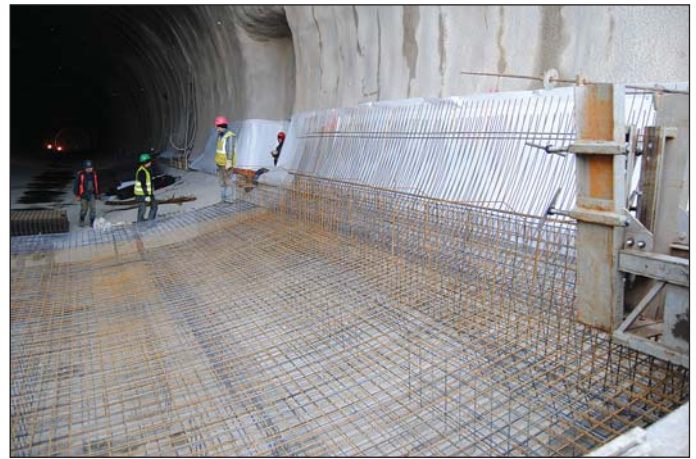
Obr. 7 Tunel Radejčín – montáž výztuže spodní klenby**Fig. 7 The Radejčín tunnel – installation of reinforcement of the concrete invert**

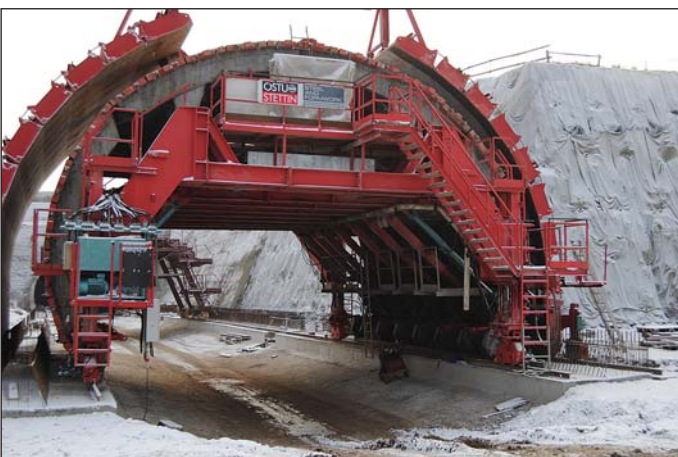
Obr. 8 Tunel Radejčín – bednicí forma pro betonáž horní klenby**Fig. 8 The Radejčín tunnel – formwork for casting of the upper vault concrete**
